Journal of Art, Architecture and Built Environment (JAABE)
Volume 7 Issue 1, Spring 2024

Integrating Architectural Heritage with Environmental Concerns: A Case Study of Clock Tower, Faisalabad

Bazla Manzoor, and Nazia Iftakhar*

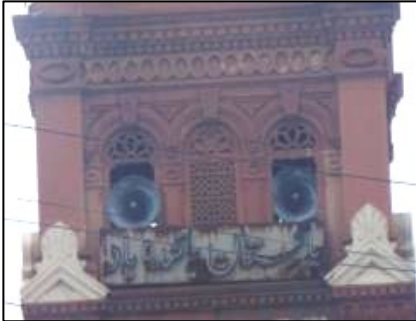
Figure 12

Since its establishment, the Clock Tower has not undergone any repair work. The original bells remain functional, however, due to the city's dense population and noise pollution, their sounds are no longer audible. In response, electronic bells were installed by the authorities, but these have been non-operational for some time due to negligence in maintenance. The installation of these electronic bell speakers in 1971 destroyed the original *Jali* work, as depicted in Figure 12, showing the current state of the distorted *Jali* and non-functional speakers.

Jali of The Clock Tower

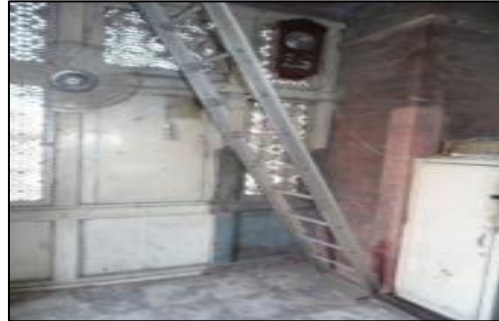
Figure 13

Approximately 30 to 40 years ago, the Clock Tower was washed for the first time in its history using fire brigades and double-decker buses. A second manual washing took place on 14th August 2015. In 2003, under orders from the town's Municipal Officer, the stairs leading to the Clock Tower from the ground floor were demolished to create an office space for police officials. The current state of the area where the stone stairs once stood is depicted in Figure 13. Currently, an aluminum ladder is used to access the first floor.

Aluminum Ladder in Place of Broken Sandstone Stairs

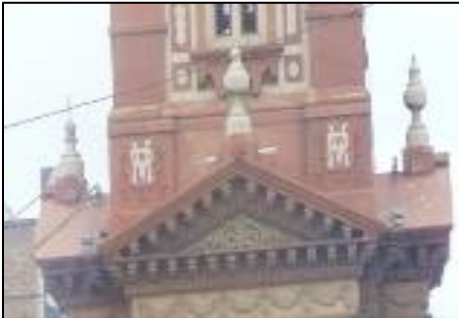
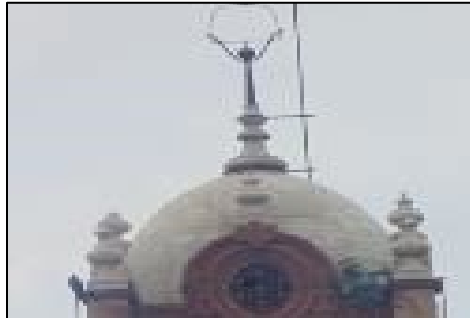
Figure 14

The white Kalse of the Clock Tower has also suffered deterioration, as shown in Figure 14. Eight "Kalse" can be viewed at each elevation of the Clock Tower, such as three above the entrance and five with the dome. The total number of Kalse installed on the tower is twelve. Observations indicate that none of the Kalse remained in their original state as each of them is partially broken (Figure 14). In 2014, landscaping work was carried out around the monument to enhance the beauty of this historic structure. Additionally, measures were taken to remove visual pollution from the

White Kale, Above the Entrance on The Left and With the Dome on The Right

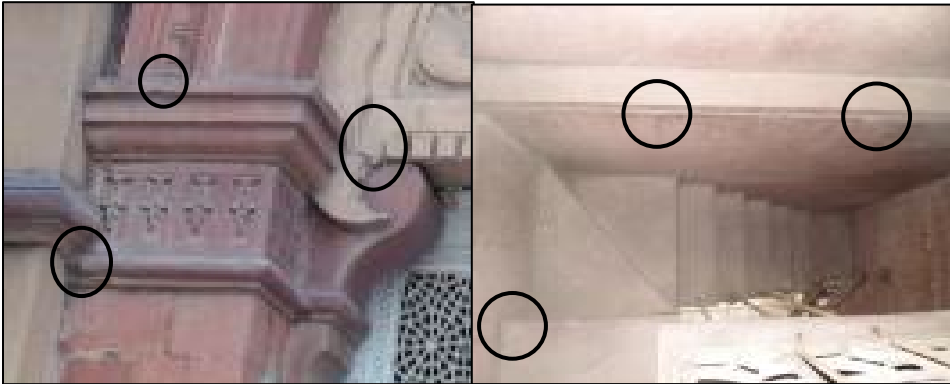
Figure 16

Chipping, the separation of small pieces from larger stone pieces, frequently occurs on edges, corners, and joints. The Clock Tower exhibits this chipping problem, as highlighted by the black circles in Figure 16. Chipping has been observed on nearly all parts of the Clock Tower, both interior and exterior. The primary causes of it include poor maintenance and the weakening of the stone's external layer due to air pollution, such as smoke from nearby shops and vehicles, as well as dust particles. This chipping not only spoils the appearance of the Clock Tower for local visitors and tourists but also leads to the progressive deterioration of the structure, particularly at its corners and edges.

Chipped Edges and Corners of the Clock Tower

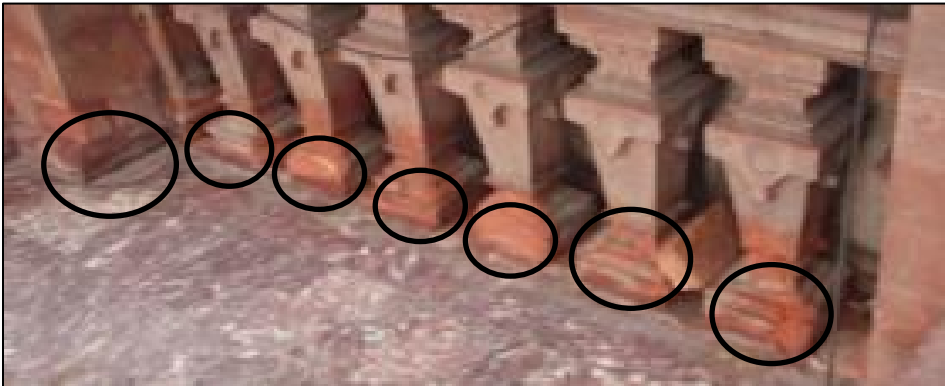
Figure 17

Flaking, as depicted in Figure 17, is a problem where small flat pieces of stone get separated from a larger stone surface. Flaking has been observed at the base of the Clock Tower. This issue arises due to moisture that accumulates at the tower's base after rainfall and washing of the circular path around it. The presence of this moisture is largely due to inadequate maintenance practices, such as improper drying after rain and washing.

Flaked Base of the Clock Tower

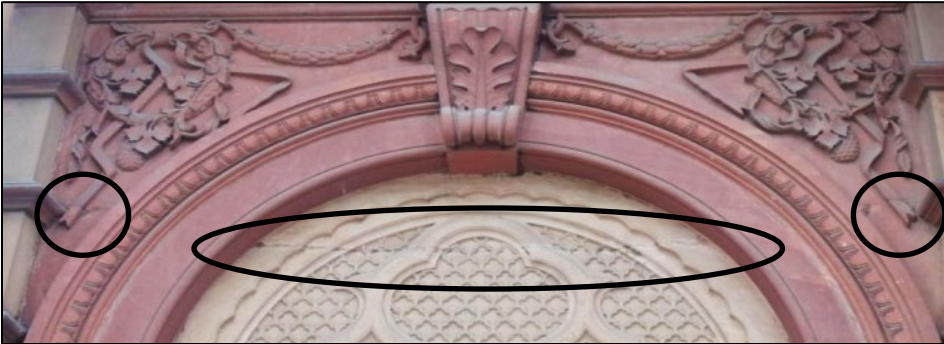
Figure 18

Cracks have been observed on various parts of the Clock Tower, as shown in Figure 18. These cracks are attributed to thermal movement, resulting from the rising temperatures in the city. This observation was confirmed by the District Officer Environment, Faisalabad during a visit to the tower. Since these cracks are caused by thermal movement, they are not found in the interior of the building, as the exterior of the Clock Tower is

Cracking on the Ground Floor

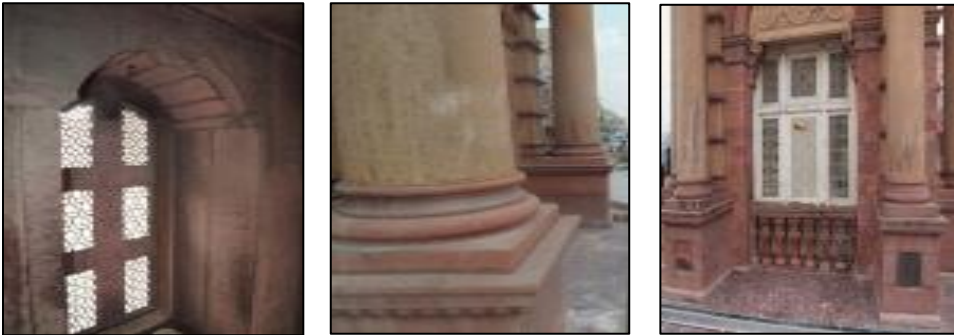
Figure 20

Discoloration and smoke deposits have been observed on various parts of the Clock Tower, as shown in Figure 19. The primary cause of this discoloration is air pollution resulting from smoke emissions from restaurant and vehicular traffic around the Clock Tower. Additionally, black deposits are visible on the stone surfaces engraved in the interior of the Clock Tower, as depicted in Figure 20.

Black Deposits on the Exterior and Interior of the Clock Tower
