- Title:** Architectural Conservation Plan of Baha-ul-Halim's Tomb at Uch Sharif
- Author (s):** Zeshan Ashraf<sup>1</sup>, Saud Kamal<sup>2</sup>, Yasmeen Abid Maan<sup>3</sup>, Sumbal Shahbaz<sup>4</sup>, Muti-ul-Haq<sup>5</sup>

# Architectural Conservation Plan of Baha-ul-Halim's Tomb at Uch Sharif

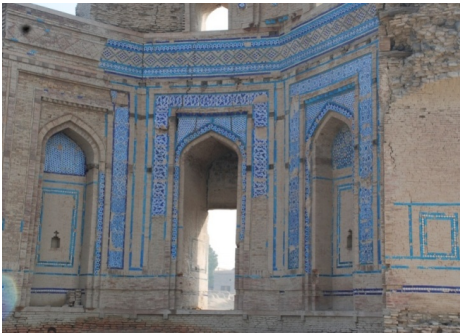
**Figure 1 (a)**

*Interior of the Shrine Baha-ul-Halim*

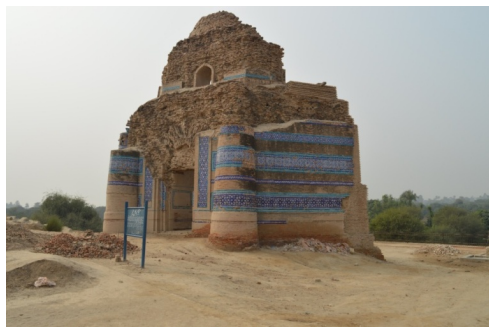
**Figure 1 (b)**

*Damaged Area of the Shrine*

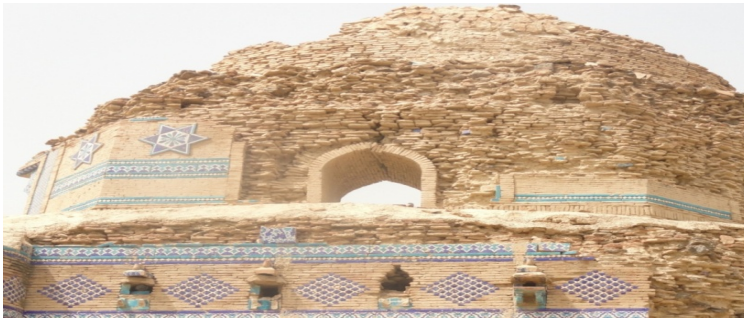
## Figure 2

### *Damaged Dome of the Shrine*

It is tough to recommend a form for the dome of the structure. However, it is possible that the dome had four centered profiles. It also had lime plaster and a ring of glazed tiles. Small remnants of these details are still visible.

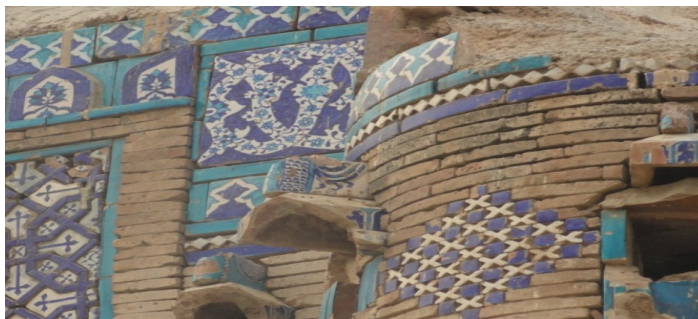
## Figure 3

### *Exterior of the Shrine has Glazed Elements*

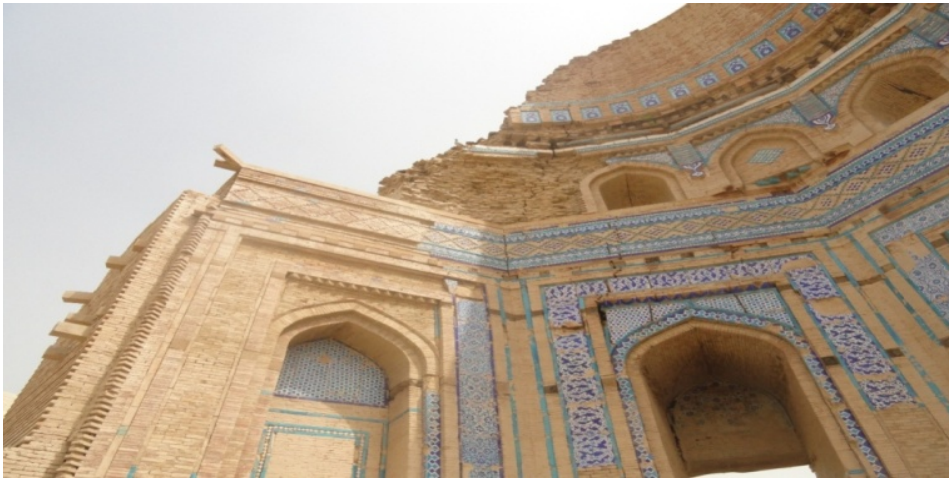
## Figure 4

*Interior of the Upper Part of Shrine*

The octagonal base is negotiated by the circular dome and has three transitional zones. The first transition is towards the turquoise dentils used to decorate the 16-sided drum comprising a round clerestory window. Projecting brick panels along with glazed architectural elements are attached to the surface of the wall dividing the arched niches, as shown in Plate 5. A wooden lintel is used to support the bracket at the corner of the drum that negotiates the transitions from the drum to the dome's base.

The southern façade bears traces of the original decorative element used for the lower base. The arches recesses have missing decoration, only its traces are visible on the eastern façade. At the dome, there is plaster's fraction with embedded tiles and it shows the decorative outline. The inner wall of the south entrance has a line of lime that specifies the original floor level. There are two holes located at the same height as the beam of the eastern faced depicting the elimination of timber element, as shown in Figure 4.

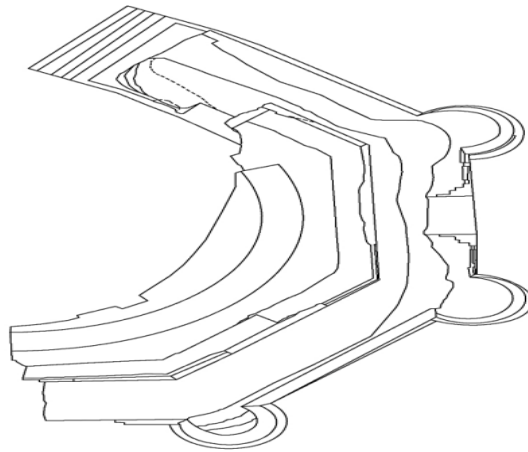
**Figure 7**

*Second Floor Plan of Baha-ul-Halim's Tomb*

Most frames and niches in the base level still exist. The brick cladding of the northern façade has been damaged. To the south end at the squinches, timber beam and three courses of brick as well as parallel ring beams with round brackets, are missing from several places. The entire surface of the sheath has gone from the northern end, as shown in figures 7 and 10.

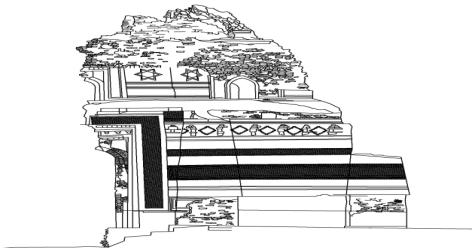
**Figure 10**

*South Elevation*

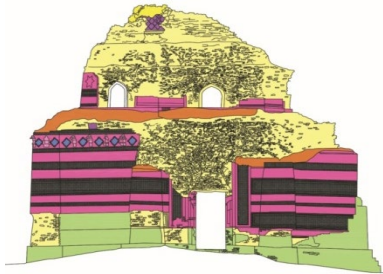
**Figure 24 (b)***Material Drawing (East Elevation)*

GLAZED BIRD HOUSES
 	GLAZED MOSIAC
 	GLAZED TILE WITH PATTERN
 	MODERN FIRED BRICK
 	ORIGINAL FINE FIRED BRICK
 	ORIGINAL ROUGH FIRED BRICK
 	MUD MORTAR
 	CEMENT MORTAR
 	GLAZED MOULDED BRICKS
 	GLAZED END PLUGS
 	GLAZED BRICK
 	GLAZED MOLDED TILES
 	TIMBER
 	GYPSUM
 	PLASTER
