Journal of Art, Architecture and Built Environment (JAABE)
Volume 6 Issue 1, Spring 2023

Title: **Reviving the Forgotten, Diminishing Glory of Sikh Heritage: A Case Study of Haveli Ranjit Singh Gujranwala, Pakistan**

Author (s): Ayesha Ahmad, Faiqa Khilat

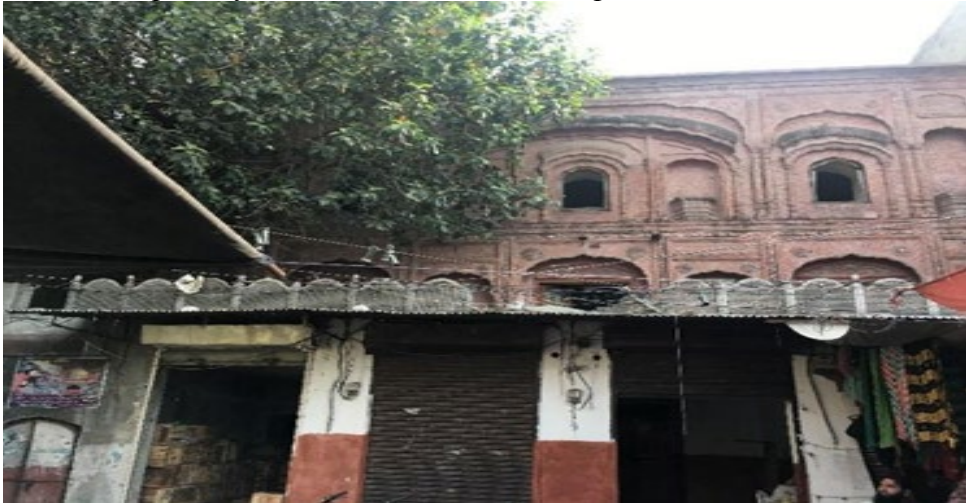
Figure 2

The front area of haveli is occupied by shops which has originally empty ground (kucha of haveli, one of significant features of Sikh havelis). The façade of haveli is partially hidden by shop fronts and hawker stalls, behind this, a rusty door is situated which leads to the haveli building. (Figure 2,3,4,5).

The Front Space of Haveli Converted into Shops

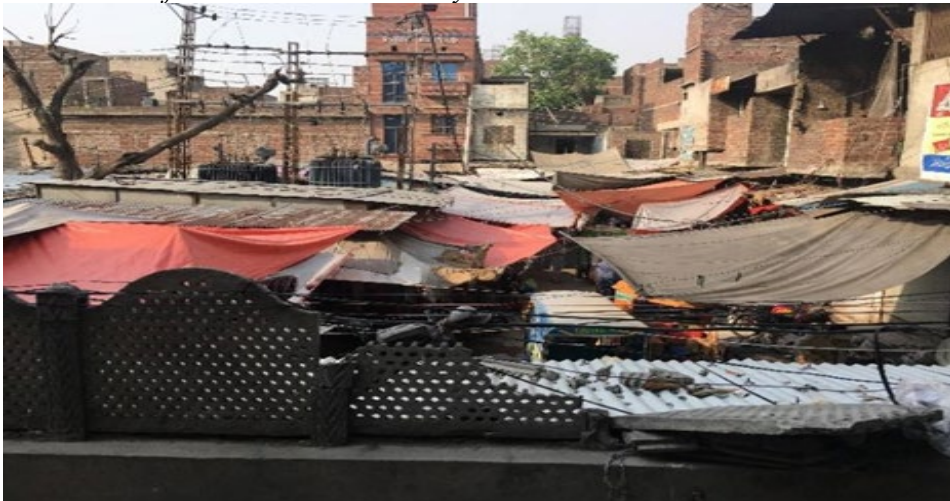
Figure 3

The Kucha of Haveli Encroached by The Venders

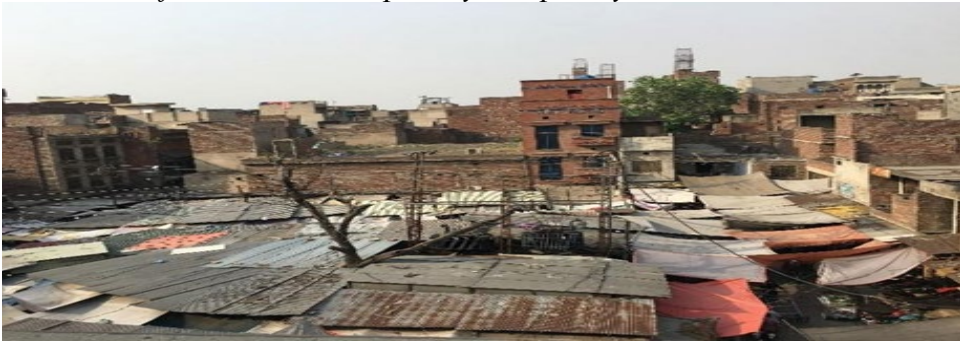
Figure 4

Arial View of the Kucha Occupied by Temporary -Structures

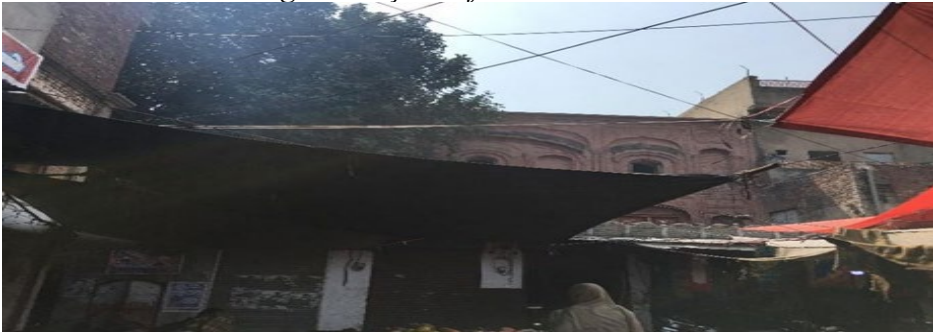
Figure 5

Encroachments Hiding the Façade of Haveli

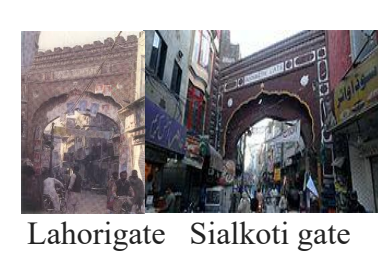
<p data-bbox="790 743 1119 777">Lahorigate Sialkoti gate</p>

Eimenabadi Gate	It was located to the south of Shera Wala Bagh, have been demolished. Lohari and Sialkoti gates are gates of same era.

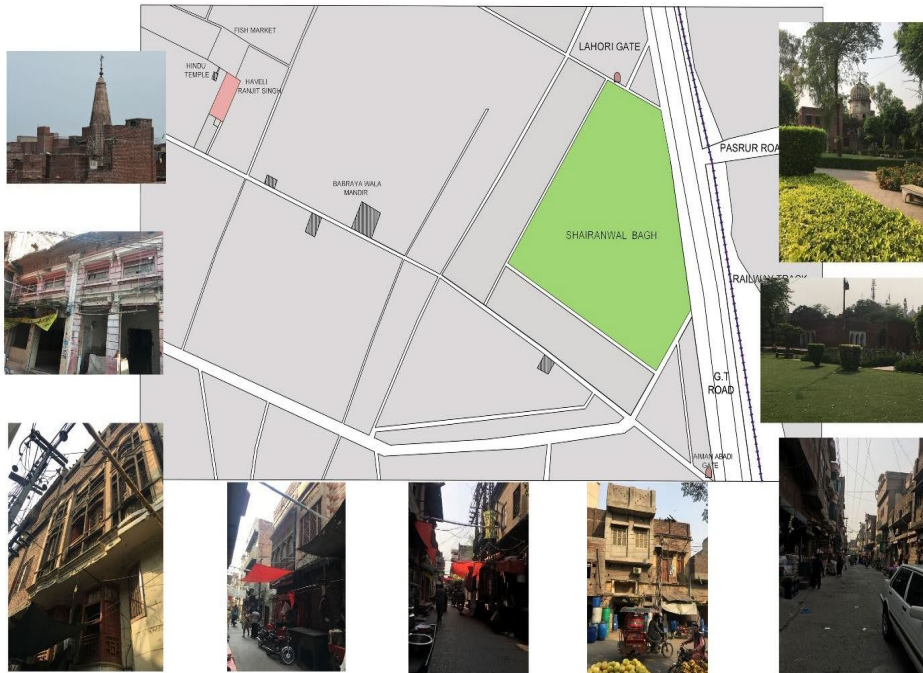
The Haveli is accessed through narrow streets, barely known by any locals. The Kucha of haveli or square, an integral part of most Sikh havelis had been encroached on by fish vendors and covered with tent structures and metaled sheets, on the façade of haveli shops had been built. The facade of haveli behind encroachments was hard to explore. At the entrance of the building, there was an open drain and a filthy smell of garbage and fish which repelled the tourists.

Figure 6
Hierarchy Map of Haveli's Route

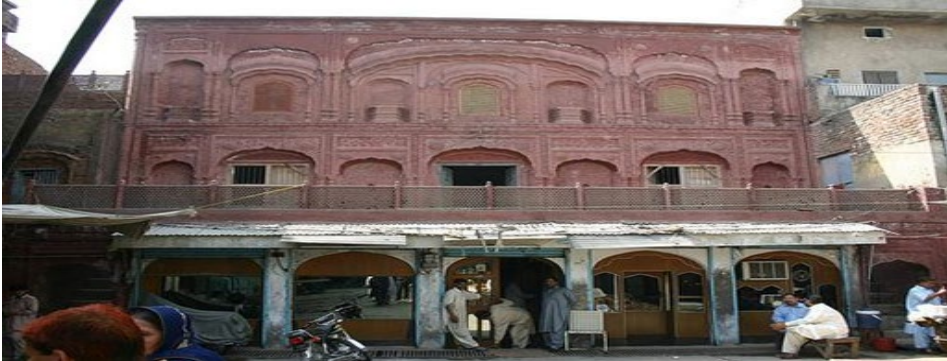
The main facade of the haveli faced south and is constructed with brick and plaster and inset with wood. Like buildings from the Mughal era, the surface is arranged as a symmetrical series of rectangular panels, separated from each other with ornamented and decorated pilasters spanned with multifold arches. On the upper ground floor, shallow niches were designed

below all of the arches. The large bay over the main entrance includes the profile of several smoothly curving bangala-style roofs (Ali, [2017](#)).

Figure 10
Façade of Haveli

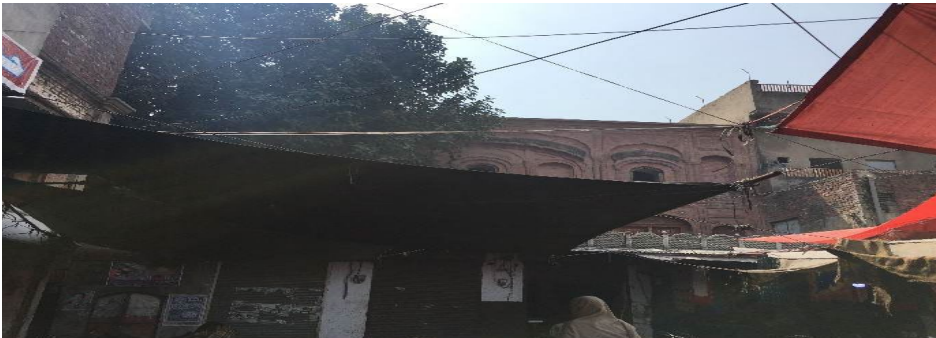
Figure 11
Encroachments Covering the Façade of Haveli

For this purpose, the route should be cleared leading to the haveli by removing the encroachments and making it accessible, as well as the building needing immediate repairs and conservation. The first stage or the rapid action plan, requires regular cleanliness and maintenance to avoid debris and vegetation; grown on walls, floors, and roof should be removed. In the long run plan, all the building elements should be conserved and repaired to the original. In the second stage, it should be utilized to give life back to the structure, for this purpose it could be converted to a museum displaying the history of the city and its developments. It could be preserved as a residence of Maharaja Ranjit Singh by decorating it with artifacts of his belongings or replicas. Encroachments should be removed from the Kucha of the haveli and it could be converted to open and green space with food kiosks for visitors.

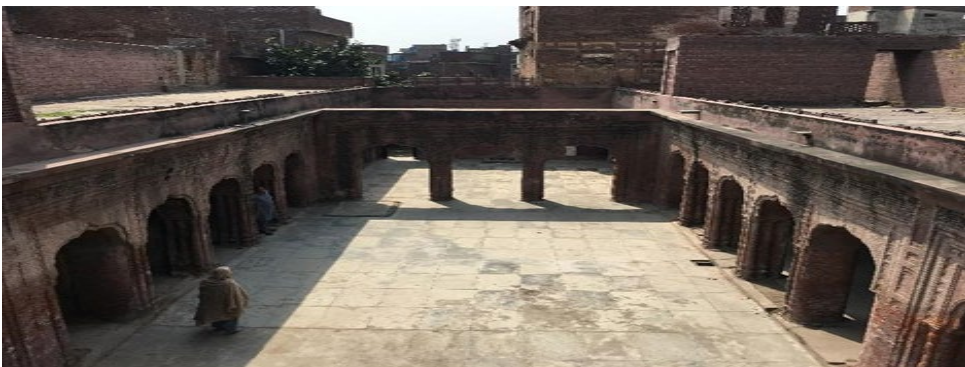
Figure 12
The Central Courtyard Surrounded by Verandas

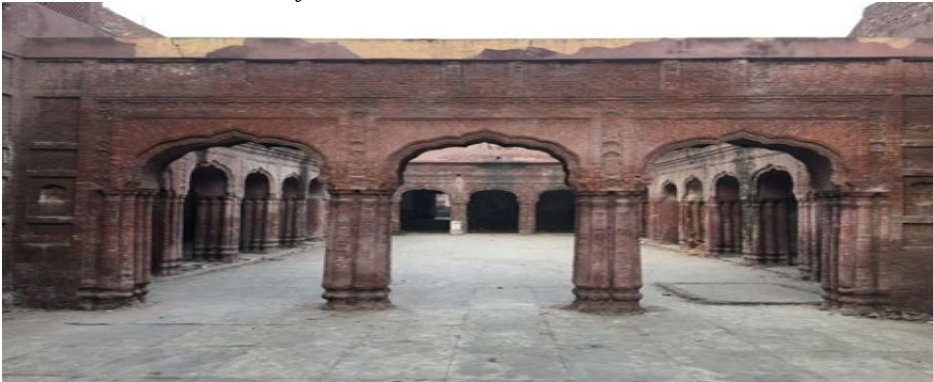
Figure 13

Intricate Detail Work of Arches and Columns

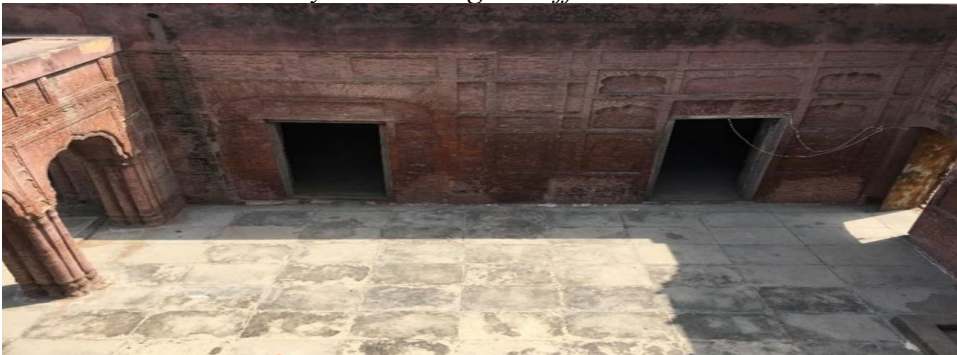
Figure 14

The Inner/Private Courtyard Leading to Different Rooms

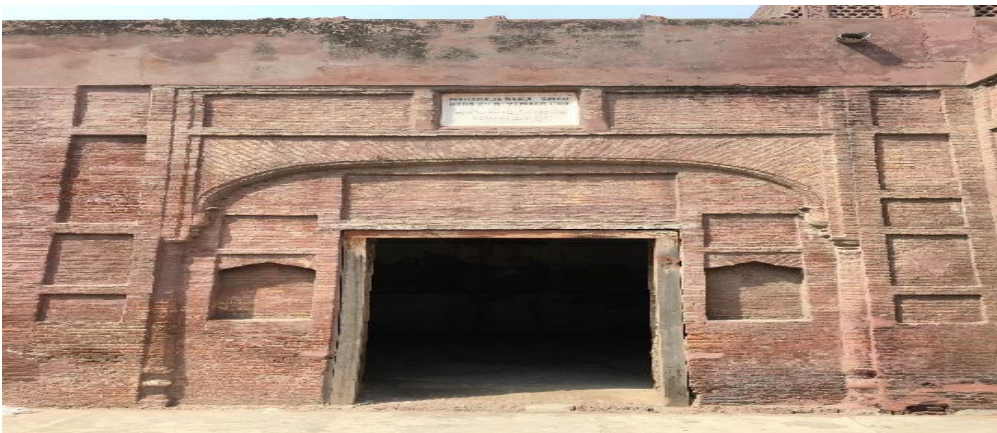
Figure15

Niches and Rich Masonry Work

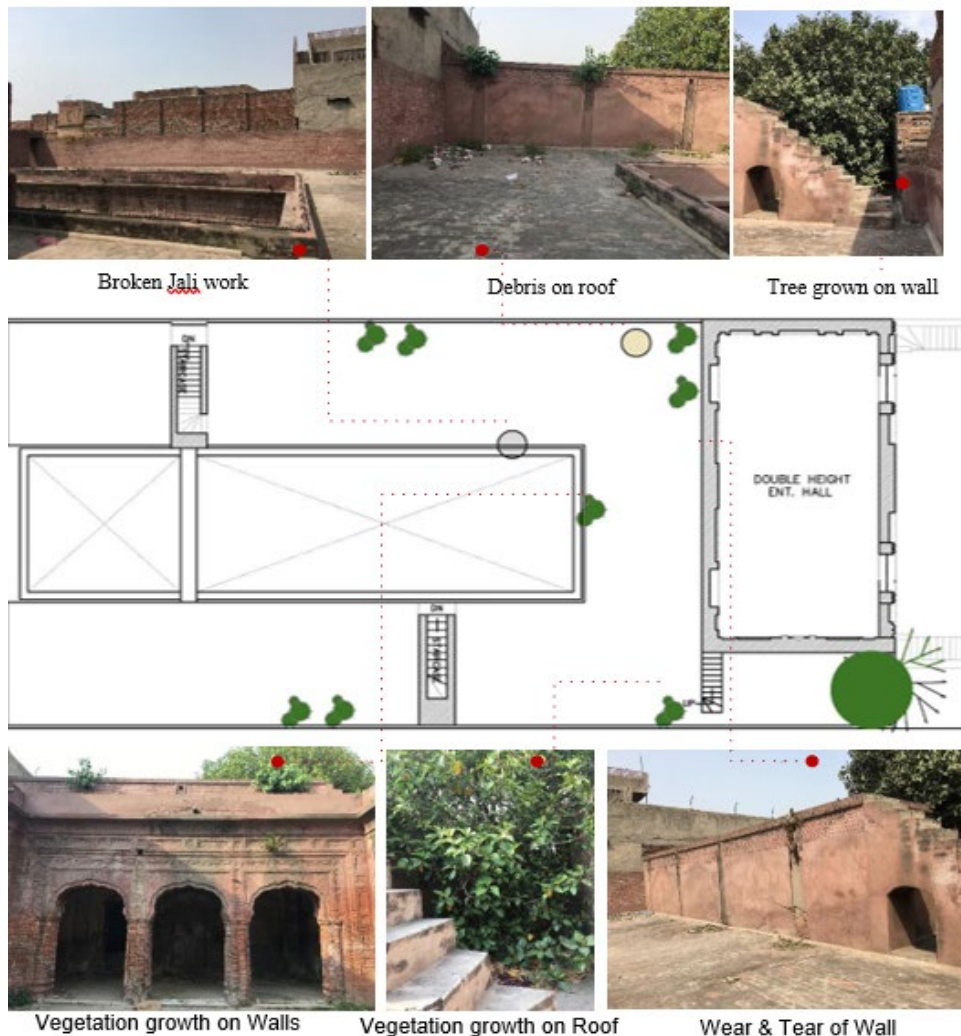
Figure 17

Decay Due to The Growth of The Vegetation in Various Parts of The Haveli

The walls and floor have been damaged in many places. The roof of the staircase had been ruined. There was leakage of water through open air vents in rooms, as a result, the walls have been exposed to water during rains. Vegetation has been grown on floors, walls and roof at many places, some of these are small plants; which were easily removable. But there is a huge tree grown on the front wall that has reached to the top of the building having deep down roots that are vulnerable to the building structure. On the whole, all the building elements have been in wear and tear condition. The building's originality and character have been buried under inappropriate conservation through ages. (Figure 17)

There is vegetation growing all over the haveli where an apparent large rubber plant has grown, reaching the top roof of the building. Which was never removed which let it to turn into a huge tree.

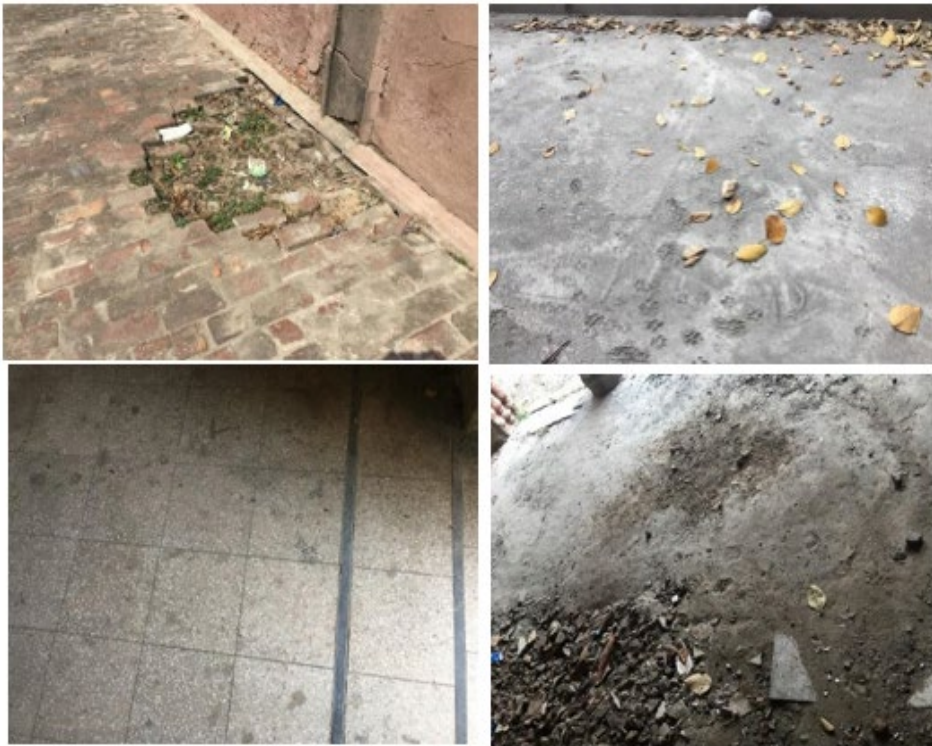
Figure18

Floors have been finished roughly with cement pilaster, somewhere terrazzo finishes, somewhere brick finishes, and somewhere totally broken in the form of debris. (Figure 18)

Floor Deterioration at Different Parts in the Haveli

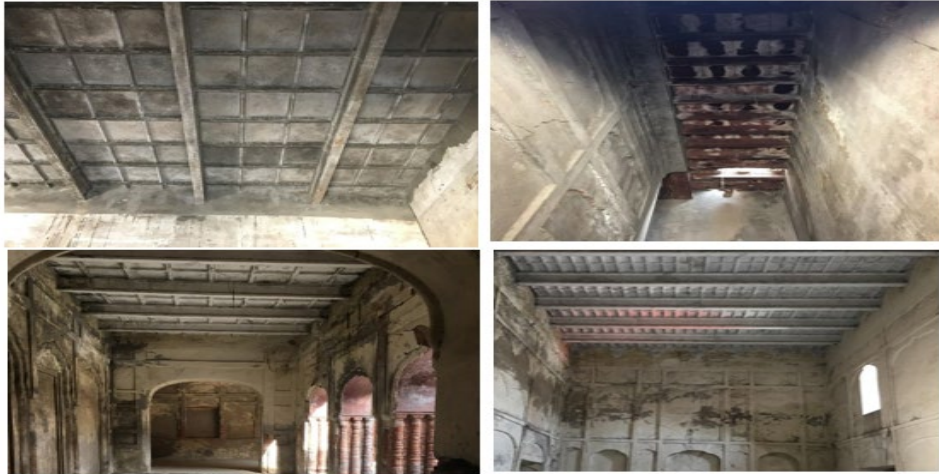
Figure 19

The ceiling has been reconstructed at many places differently; mostly precast R.C.C slabs have been used for reconstruction and repairs. The ceiling differs from space to space. The oldest ceiling found in Haveli was of the staircase which was constructed in timber and brick rest all are precast R.C.C slabs. The most recently added roof reconstruction was done in a verandah. (Figure 19)

Ceiling Condition of Different Areas

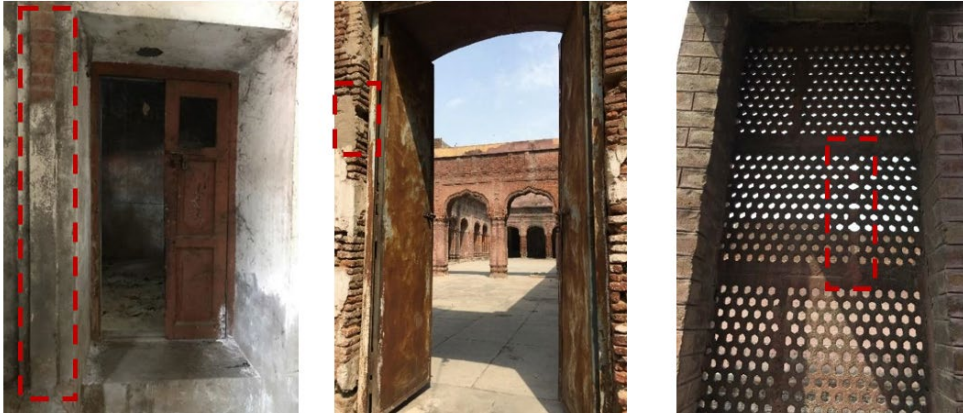
Figure 21

While inappropriate conservation included cementing of walls and brick structure, finished with local low-cost paints. Roofs replaced or reconstructed with precast R.C.C. slabs. Walls had been whitewashed which had been peeling off.

The doors, windows, and other elements of haveli were also dilapidated condition. The windows on the facade are broken and the rooms are without doors. Latterly added elements to the haveli i.e., the jali work, roof slabs, and modern colonial-sized brick, for repair and reconstruction didn't harmonize with the architecture and originality of the haveli. (Figure 21)

Inappropriate Repair Work
