Journal of Art, Architecture and Built Environment (JAABE)
Volume 7 Issue 1, Spring 2024

Title: Analyzing Walkability in Hyderabad: A Study of Sakhi Sultan Road

Author (s): Hina Kamal, Shazia Abro, and Shah Rukh Noman

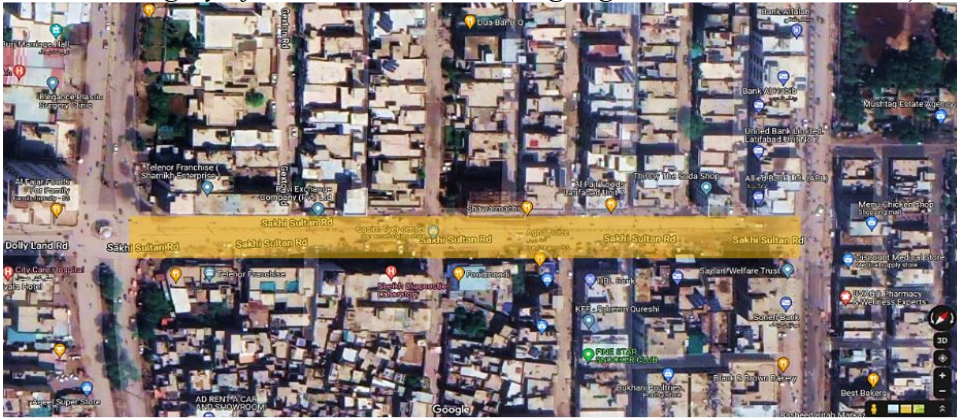
Figure 1
Satellite Imagery of the Selected Street (Highlighted with Yellow Color)

For this purpose, a street in Hyderabad named “Sakhi Sultan Road” (shown in Figure 1) was selected to analyze its present condition and explore its capability to turn into a walkable street.

The street is in Latifabad unit#7, Hyderabad, Sindh. It extends from south-west to north-east direction. It is 50 feet wide from the south-west corner and 40 feet wide from the north-east corner (Google map). On the south-west corner, there are two shops on each edge of the street namely, Zeeshan optics and White meat Chicken Shop. On the north-east corner, there are two shops on each edge of the street namely, Sindh Pan House and Saylani Welfare Trust (Ghori Dream City). The total length of the street selected for this study was 271 meters or 890 feet. Within this length, four spots were selected for in-depth understanding of walkability on this street.

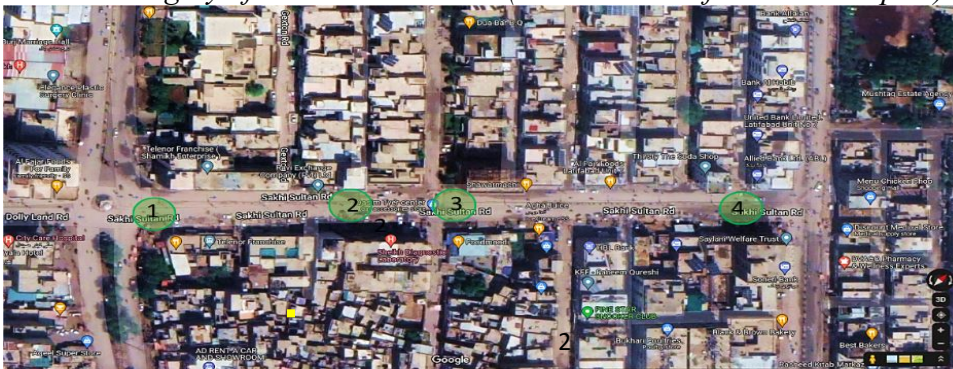
Figure 2

The four spots selected on the street are mentioned in Figure 2. Spot 2 was selected as the primary spot on the street.

Satellite Imagery of the Selected Street (Green Circles for Selected Spots)

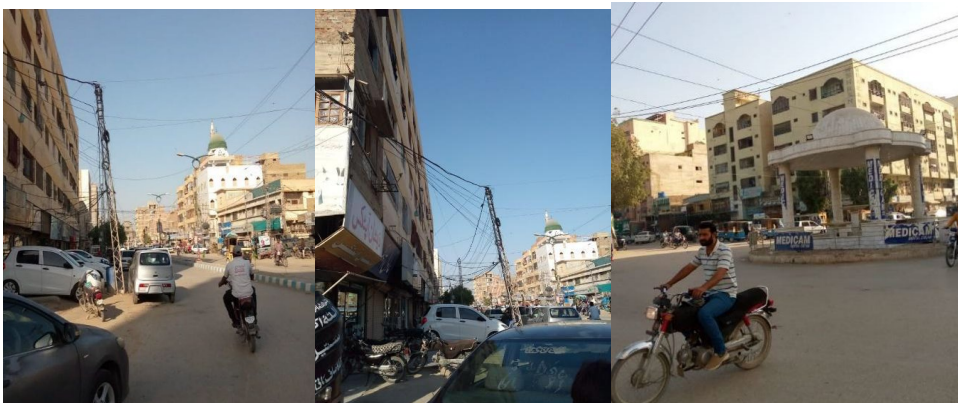
Figure 3

Figure 3(a) shows the south-west corner of the street. It also shows diversity in the form and proportion of buildings. A mosque is visible on the street from far away which acts as a landmark on the street. Buildings are lined on both edges of the street and sky is widely visible above the street. The street is in good condition and wide enough for pedestrians and traffic. It can be seen in the photograph that the footpath on one end of the street is occupied with cars and motorbikes. The shops on this edge are commercial shops and most of them are optics shops. An electricity pole can also be seen in the photograph between the traffic lane and footpath. A raised median in the center of the street along with streetlights was also found that directs two-way traffic.

Figure 3(b) shows Zeeshan optics shop and other commercial shops and all of them have transparent glass facades. The footpath area is covered with motorbikes and cars.

Figure 3(c) shows a roundabout at the end of the street. The street's surface is plain with no holes or bumps.

(a) Spot 1 Showing South-west Corner of the Street; (b) Zeeshan Optics Shop on Spot 1; (c) Spot 1 Showing Roundabout on the Street's End

Aesthetics	Status	Function	Status	Safety	Status
Diverse building forms and outdoor dining area.	✓ Outdoor dining was missing	Constructed pathways, ramps, and crosswalks.	✗ Only pathways were present.	CCTV cameras, street lighting, and phone booths.	✗ Only streetlighting was present.
Walls or trees lined on the edges of street and sky ahead.	✓	Mixed land use; diversity in building types.	✓	Speed breakers, roundabouts, traffic lights, and traffic signs.	✗ Only roundabout was present.
Landmarks and landscape features.	✓	Good street condition, and suitable width.	✓		
Adequate scale and proportion of buildings related to human scale.	✓				
Transparent glass walls and large canopies of trees.	✓

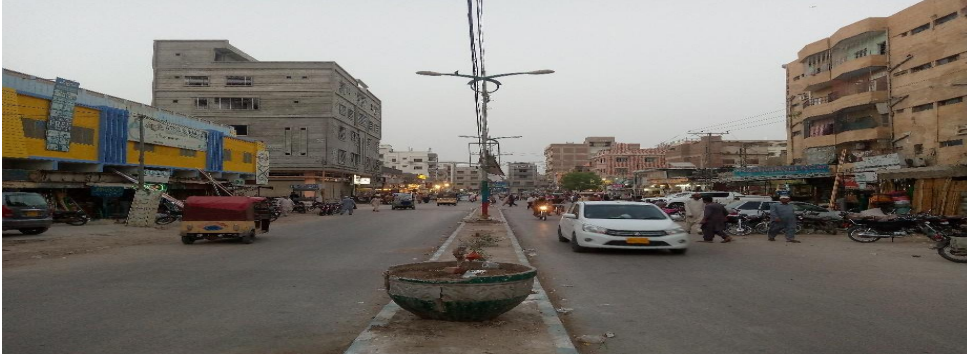
Figure 4 depicts the median in between the two lanes on the street. Streetlights and small planters are placed on the median. Diversity can be seen in types of buildings. On the right side of the photograph, there is a residential plaza and retail shops on the ground floor. On the left side of the photograph, there is a school on the first floor and hardware shops on the ground floor. Diversity can be observed in the color, material, and form of the building in the photograph. Smooth surface of the street and wide lanes are also visible in the photograph. Buildings are lined on both edges of the street and sky is wide open above the street. Some buildings show more height to width ratio than others. The footpath area is occupied with motorbikes and cars and shops have open facades, displaying their items.

Spot 2 of the Selected Street, showing its Median Separating the Two-way Traffic

Aesthetics	Status	Function	Status	Safety	Status
Diverse building forms and outdoor dining area.	✓	Constructed pathways, ramps, and crosswalks.	✗ Only pathways were present.	CCTV cameras, street lighting, and phone booths.	✗ Only streetlighting was present.
Walls or trees lined on the edges of street and sky ahead.	✓	Mixed land use; diversity in building types.	✓	Speed breakers, roundabouts, traffic lights,	✗

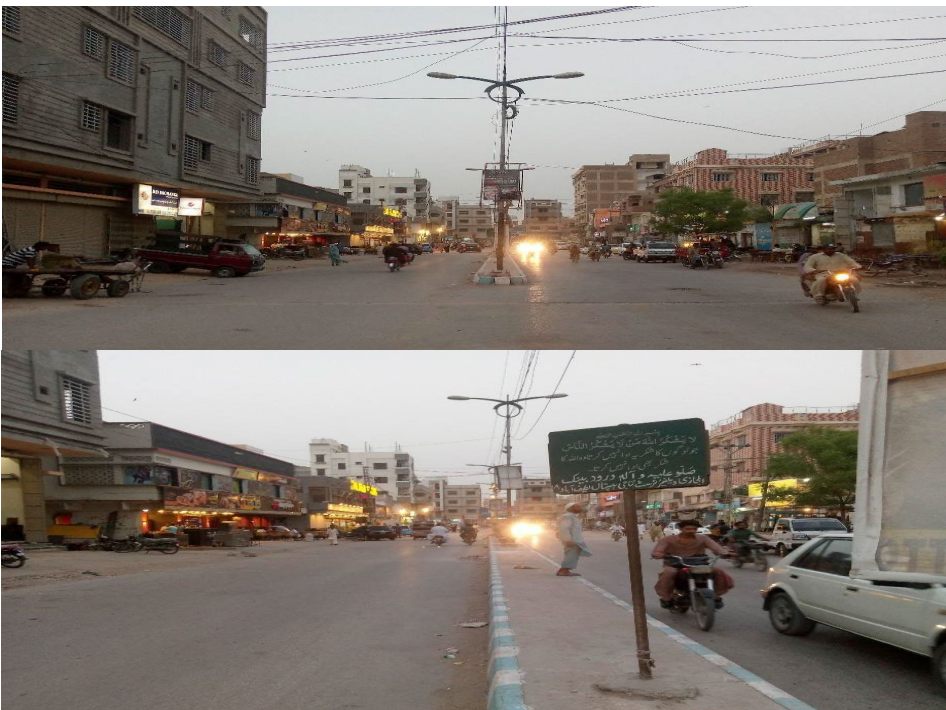
Figure 5

Figure 5(a) and (b) show variety in the heights, materials, and colors of the buildings. Outdoor dining is also visible on this spot, where two restaurants including Al-Fajr Foods and Shawarma Chi provide a great outdoor sitting arrangement in front of their shops. On this spot, two other streets on the right and left side intersect with this street that can be seen in figure 5(a), where a break is provided in the median to turn around. Buildings are rowed on both edges of the street, with a few trees, and a

broad view of sky is also visible above the street. Al-Fajr Foods acts as a landmark on this street which is known for its tasty food and people come here to enjoy it. Buildings or structures are not very tall and most buildings expand horizontally which relates to human scale. Facades of shops or restaurants are either open or have glass front. The street is in fine condition with a raised median in the center with streetlights. The street is sufficiently wide to accommodate traffic and pedestrians.

- (a) Spot 3 of the Selected Street, showing Diverse Activities on the Street
- (b) a Closeup of Spot 3, showing its Various Features

Aesthetics	Status	Function	Status	Safety	Status
Diverse building forms and outdoor dining area.	✓	Constructed pathways, ramps, and crosswalks.	✗	CCTV cameras, street lighting, and phone booths.	✗
Walls or trees lined on the edges of street and sky ahead.	✓		Only pathways were present.		Only streetlighting was present.
Landmarks and landscape features.	✓	Mixed land use; diversity in building types.	✓	Speed breakers, roundabouts, traffic lights, and traffic signs.	✗

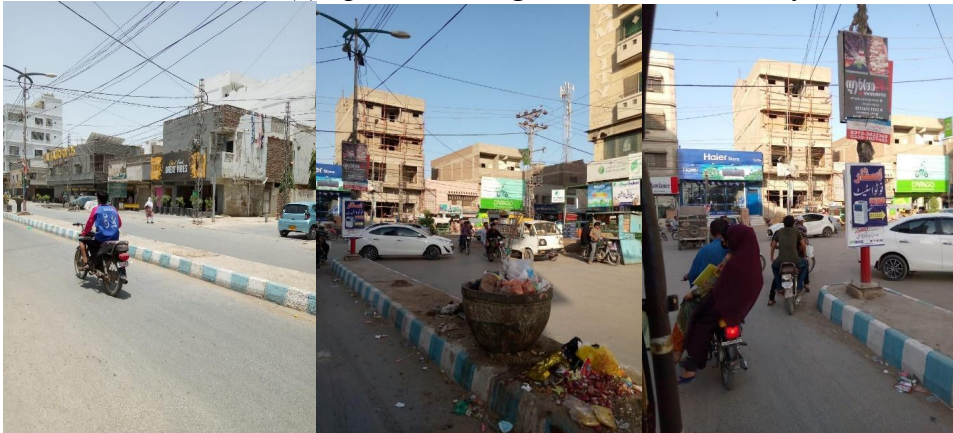
Figure 6

(a) Spot 4 showing Street towards South-west Direction; (b) Spot 4 towards North-east Direction; (c) Spot 4 showing North-east Corner of the Street

Figure 6(a) shows some horizontally stretched buildings that refer to human scale and an outdoor sitting for dining is also visible. Many small planters are placed on the median and in front of a restaurant. Buildings can be seen on one edge (west side of the street) and the sky is widely visible above the street. The median between the two lanes is wide enough to accommodate planters, streetlights, and sign boards that can be seen in the photograph. The street is clean, plain, and wide, having shops with open facades and parking on the footpath area.

Figure 6(b) shows the lack of maintenance on this spot, while a planter can be seen on the median with trash in the photograph. A residential plaza named Ghouri Dream City (right side of the photograph) on the north-east corner of the street can be seen. Raised median with streetlights and overhead sky is openly visible on this spot. The footpath area is occupied with kiosks, cars, and motorbikes.

Figure 6(c) shows the north-east end of the street and it has no roundabout on this spot. Traffic is moving in four directions and turning around without any circle or roundabout. The condition of the street is satisfactory.

Aesthetics	Status	Function	Status	Safety	Status
Diverse building forms and outdoor dining area.	✓	Constructed pathways, ramps, and crosswalks.	✗ Only pathways were present.	CCTV cameras, street lighting and phone booths.	✗ Only streetlighting was present.
Walls or trees lined on edges of street and sky ahead.	✓	Mixed land use; diversity in building types.	✓		
Landmarks, and landscape features.	✓	Good street condition, and suitable width.	✓	Speed breakers, roundabouts, traffic lights, and traffic signs.	✗
Adequate scale and proportion of buildings related to human scale.	✓				
Transparent glass walls, and large canopies of trees.	✓
