Article: **Condition Assessment: Identification of Threats and Review of Existing Structures of Wah Gardens for Prioritization of Treatment Recommendations**

Identification of Threats and Review of the Existing Structures of Wah Gardens for the Prioritization of Treatment Recommendations

Abstract

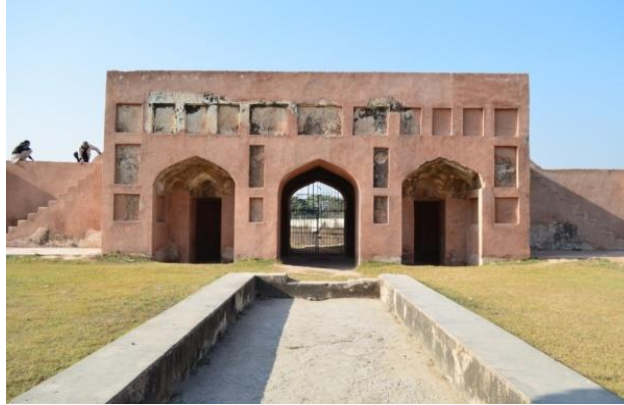
Figure 4

The Existing Muqarnas Details and Fresco Work from the Mughal Times Have Almost Vanished

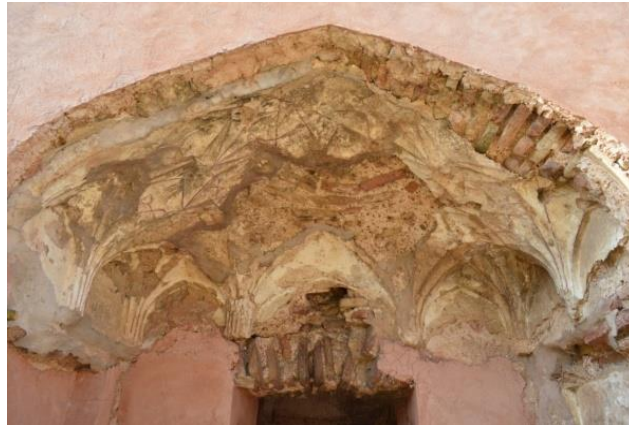
Figure 5

The Existing Condition of the Western Gate After the Conservation Work Done by the Department of Archaeology, Pakistan

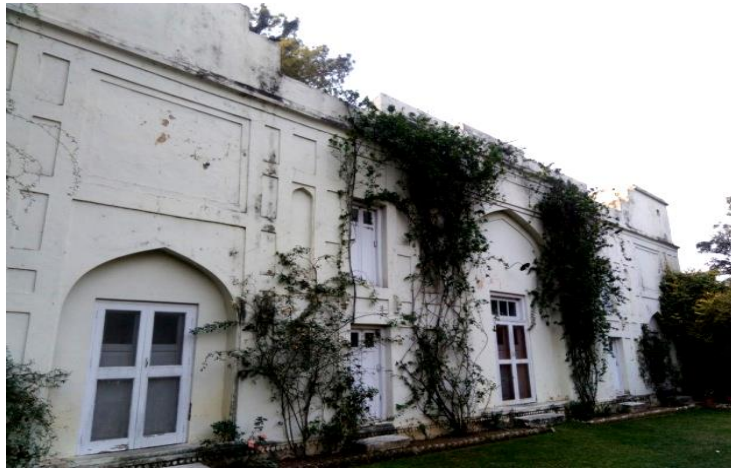
Figure 6

Gardens. The palace consists of a large hall with adjacent rooms. The entrance way has been replaced by modern glazed doors. The interior of the palace was once decorated with fresco paintings and the exterior shows sunken panels of different shapes and sizes. The palace also has a large water pond on its eastern side (Khan, [1992](#)).

Eastern Facade of the Farudgah Palace

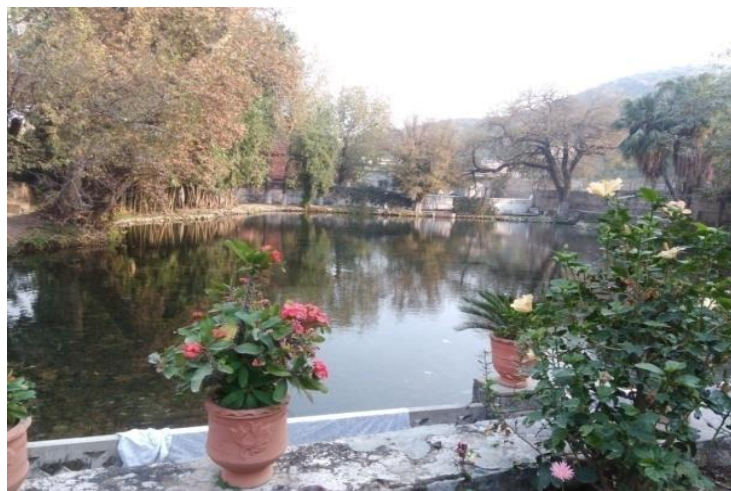
Figure 7

Existing Condition of the Water Pond in Front of the Farudgah Palace

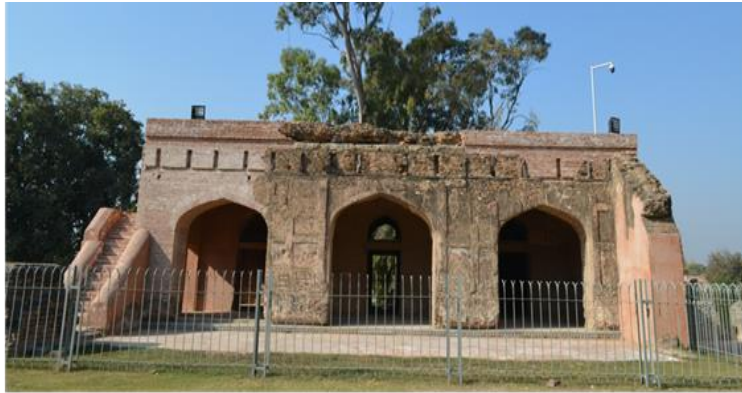
Figure 8

Existing Condition of Baradaris in Second Terrace

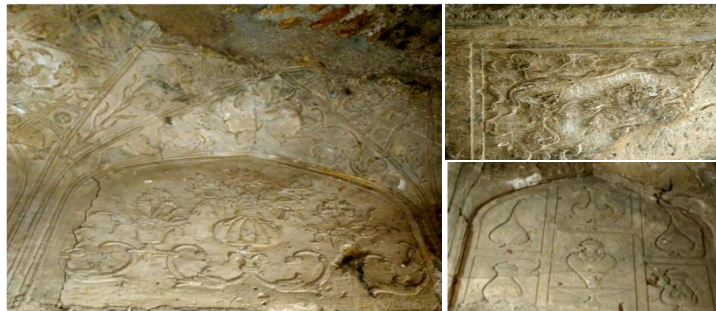
Figure 9

The ceiling of the baradaris is decorated with honey comb pattern intended to create a constellation of stars. Most ornamental details have vanished, although the traces of stucco detail work is still visible and forms vegetal and floral patterns along with aftaba, vases, bottles etc. The flooring was done in tessellation pattern in sang-e-khattu, sang-e-musa and marble.

Ornamental Details of Baradaris

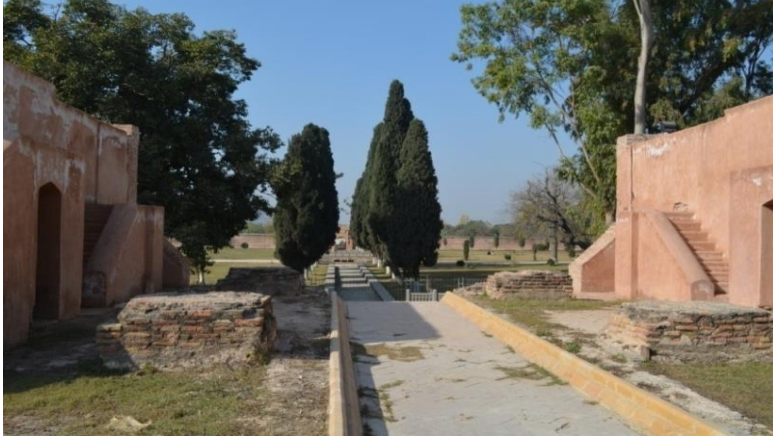
Figure 10

Structural Remains of Raja Maan Singh's Baradari

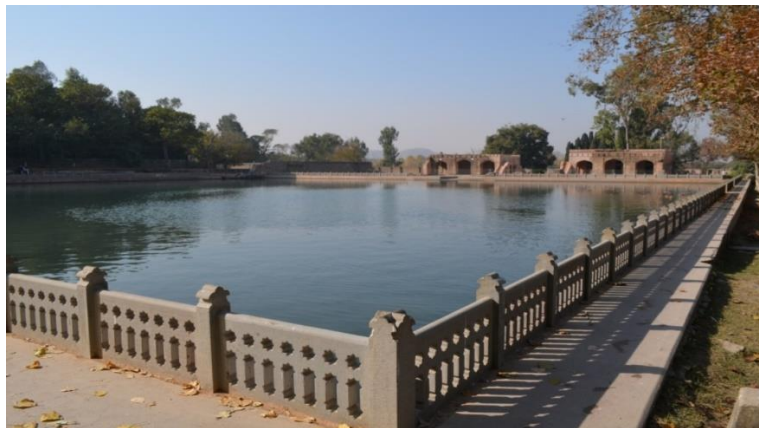
Figure 11

Main Water Tank Fenced with Grey Sand Stone Jali Work

The main water tank is surrounded from all sides with jalis made of stone slab which were discovered during the excavation of the tank. The tank has seven arches on its eastern side that provide access to the incoming current of water from natural springs. Only one arch is blind out of the seven arches. The tank consists of a platform and mahtabi on its eastern end, while the western side provides connection to a central canal for the flow of water. The tank has a depth of 5'-3" at the eastern side and 5'-9" at the western side while maintaining the slope to let the water flow with speed (Khan, [1996](#)).

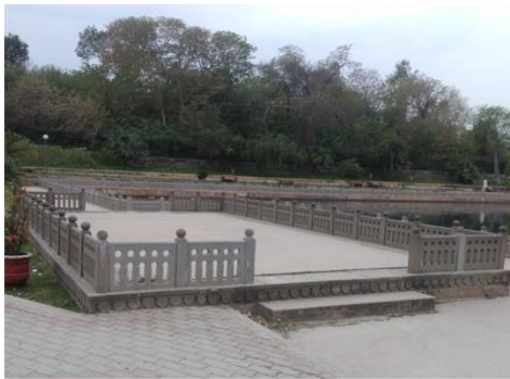
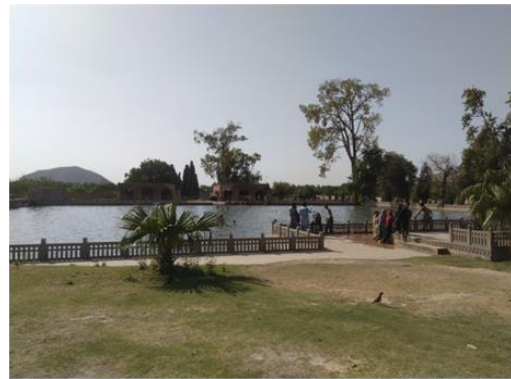
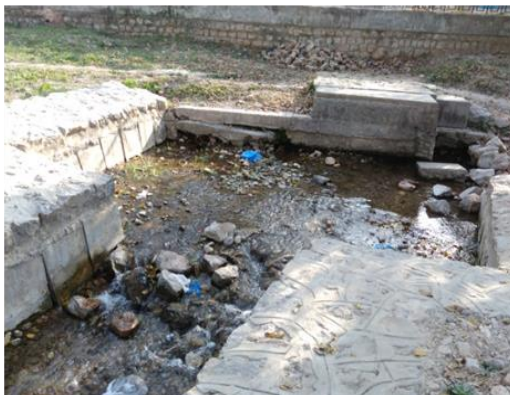
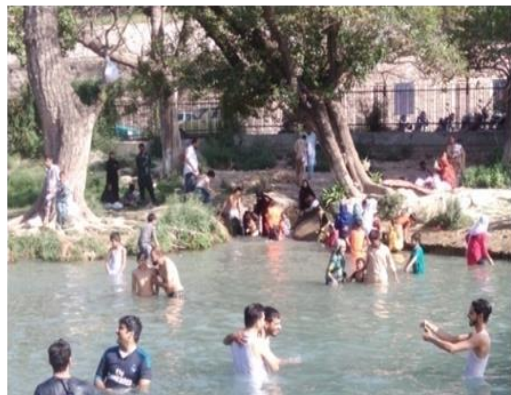
Figure 12

(a) Mahtabi Adjacent to Main Water Tank (b) Overview of the Water Tank (c) Point of Natural Springs (d) Water Pond Beyond the Main Water Tank

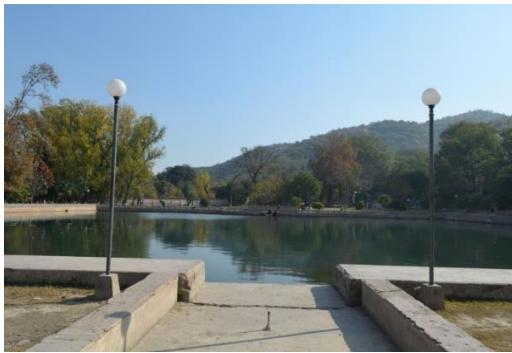
Figure 13

Central Canal Facing the Main Water Tank

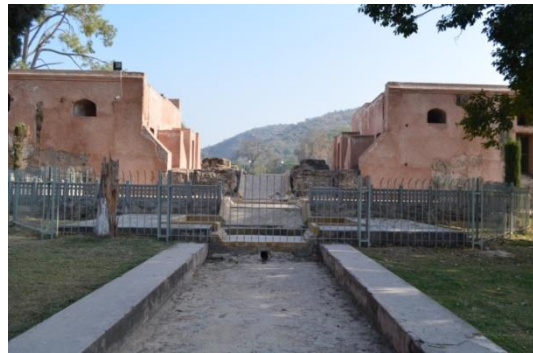
Figure 14

Central Canal Along with Adjacent Baradaris

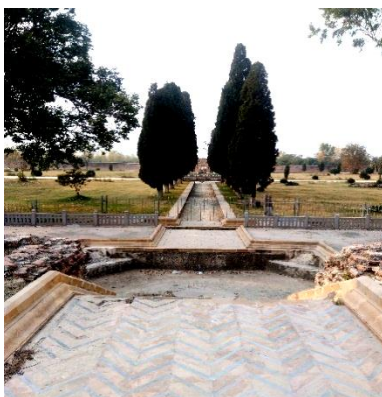
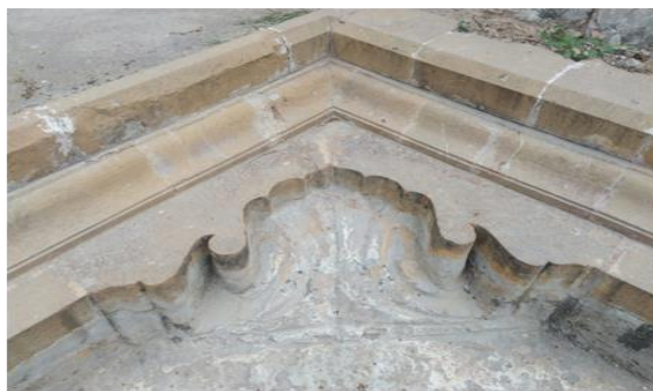
Figure 15

(A) Chevron Pattern Built in Sang-E-Abri and Sang-E-Khattu, (B) The Ornamental Pattern at the Corner of the Tank Within the Central Canal

The water from the main tank enters the central canal, flows over the cascade and fills up a small tank having a fountain at its centre. The corners of the tank are stylised with ornamental patterns. From here, the water again flows over another cascade and enters another tank which also has a fountain in it. This fountain is embedded in an eight petal flower base and is constructed in sang-e-khattu. Beyond the stone bridge, the central canal is built in a chevron pattern with sang-e-abri and sang-e-khattu including the cascade. The central canal is aligned by tall cypress trees in the lower terrace planted in the early 20th century

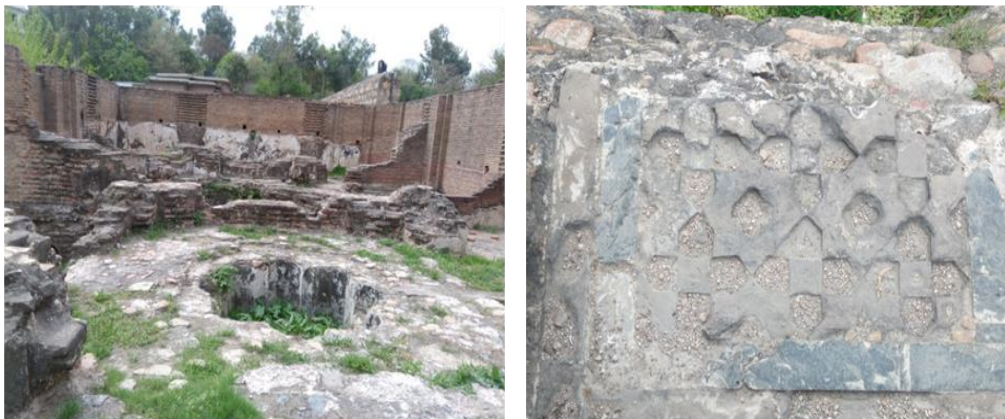
Figure 16

Existing Condition of the Hammam and the Geometric Patterns on its Floor

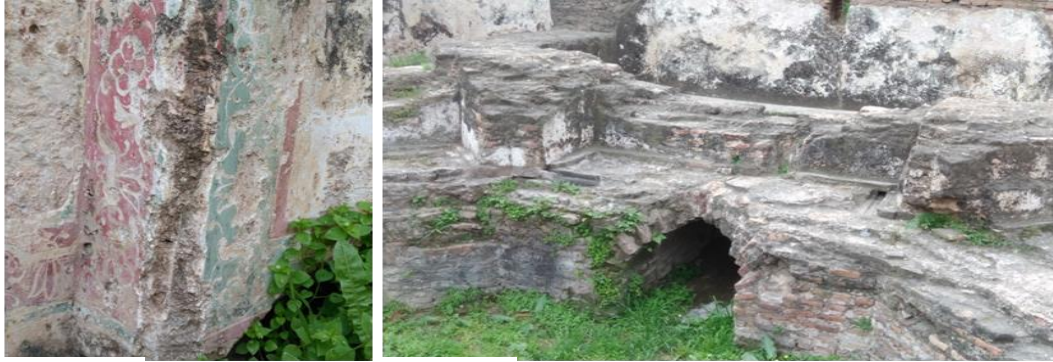
Figure 17

(a) Terraces of Ornamental Details on the Southern Wall of the Hammam, (b) Passage for the Supply of Water to the Hammam

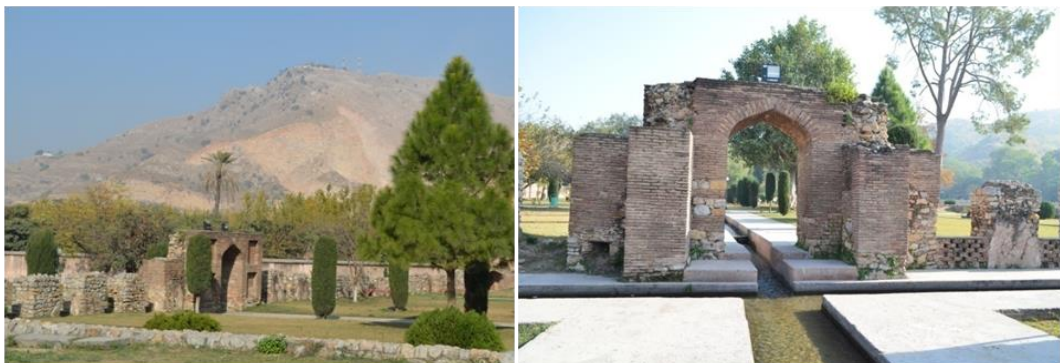
Figure 18

(a) Paen Bagh in the Middle Terrace with the Remains of Screen Wall (b) The Arched Way of Paen Bagh

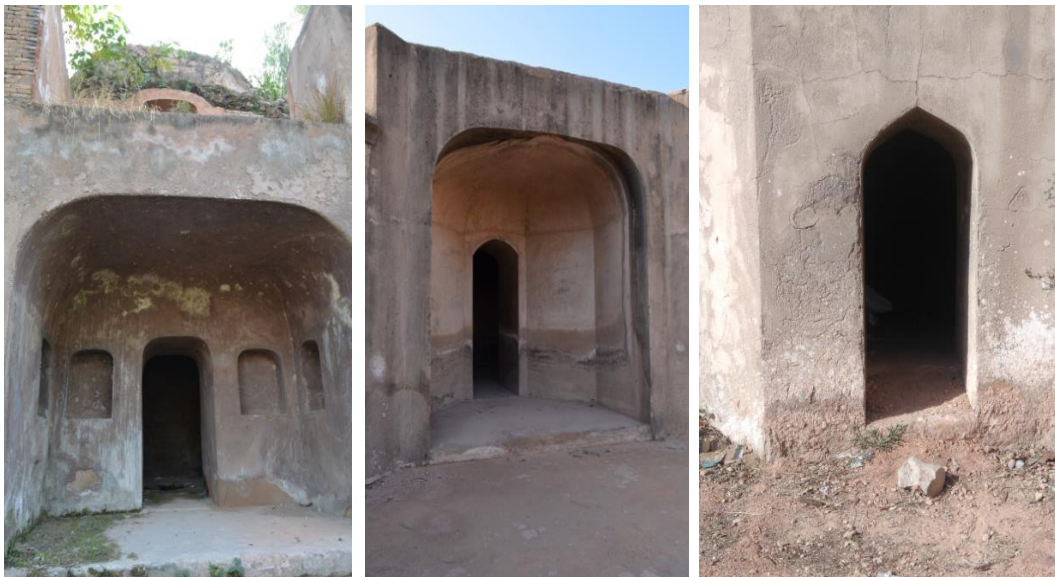
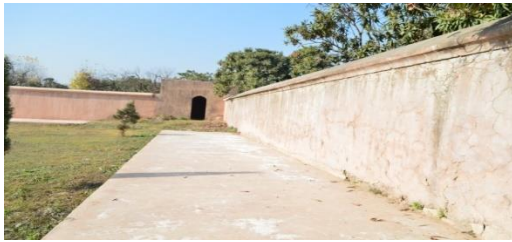
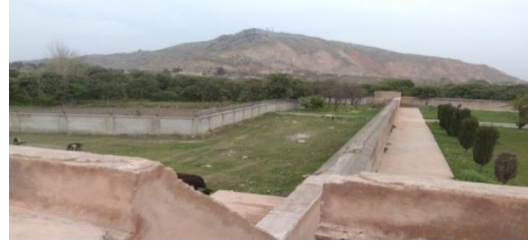
Figure 19

The turrets on the northern side of the garden are small rooms with an arched access. The turret on the south-western wall is also a single storey structure with arched openings and niches provided in the room. The other southern turret is a double storey structure with a staircase leading to the roof. It has two rooms, one on the ground level and the other is just above the staircase with an arched opening. It is also provided by niches. The ceiling of the room is built in low heighted dome style. In the centre of the room a small octagonal basin is present.

(a) Turret in the South-East Part of the 3rd Terrace (b) Turret in the South-West Part of the 3rd Terrace (c) Turret in the North-East Part of the 3rd Terrace (d) Turret in the North-West Part of the 3rd Terrace (e) Boundary Wall of Wah Gardens

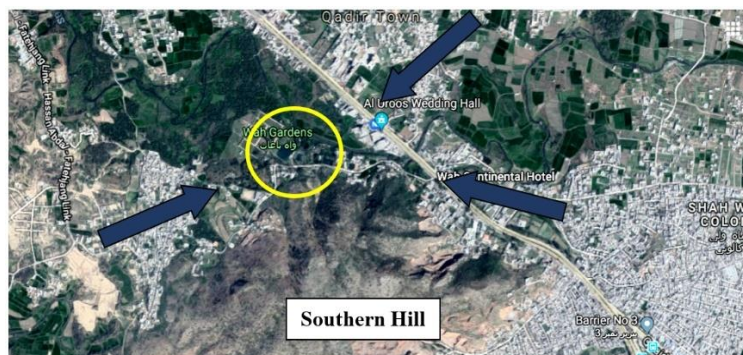
Figure 20

Currently, a major threat to Wah Gardens is the urban sprawl. The continuous spread of residential and commercial encroachment towards the Wah Gardens is an alarming situation for the heritage site. The urban sprawl is not only spoiling the aesthetic character of the area but also causing changes in the environmental and weather conditions of the city of Wah Cantt and Wah Gardens. The north-west side is still covered with thick vegetation but this land is the private property of the Khans of the village Wah and remains under threat, as in future it could be used for residential or commercial development, thereby changing the surrounding context of the site (Ali, [2018](#)).

Arrows Indicating the Movement of Residential and Commercial Encroachment Towards the Garden

A distance of 200m should be maintained from the heritage site of the new constructions according to the guidelines in order to maintain its original surrounding context. Residential or commercial structures should remain outside the marked area. The department needs to reconsider the external boundary as it is not fulfilling the said requirement.

In order to control the rapid development around the Wah Gardens, the Department of Architecture should take legal steps for the acquisition of the surrounding green land in order to maintain the surrounding landscape of the garden, as a prime attraction of the place is its natural environment.

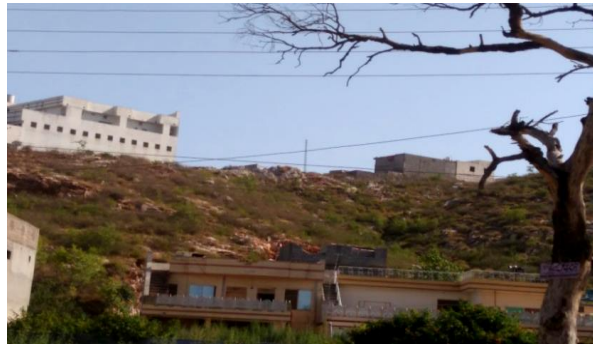
Figure 21

The southern hill that once was the part of the gardens has stopped the residential and commercial encroachments towards the gardens in this direction, although a cluster of buildings could be seen on the opposite side. However, a number of illegal constructions can be seen on this hill and their number is increasing rapidly. Fig. 21 shows some of the illegal constructions on the southern hill.

Illegal Constructions on the Southern Hill

Action against the built structures around the Wah Gardens and on the southern hill is badly needed as the number of built structures is increasing rapidly and they are spoiling the aesthetics of the area. Heavy fine along with the demolishing of the structures is required so in future it remains safe. The continuous supply of water from natural springs requires the limiting of development around the complex and a lesson should be learnt from the plight of the Katas Raj Temple, where unplanned and unstudied construction resulted in the extinction of water.

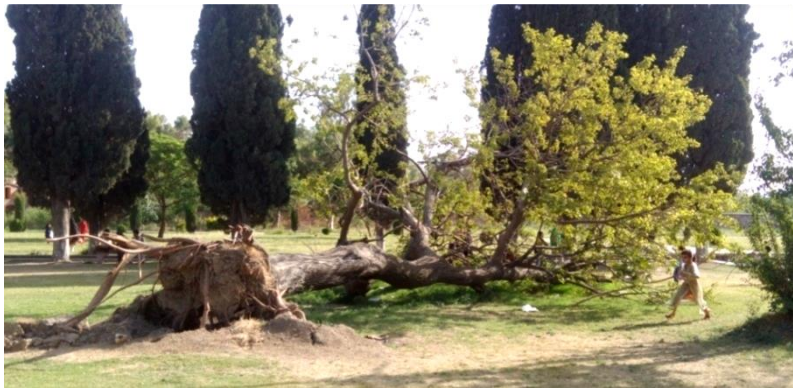
Figure 23

Wah Gardens are present in a region that is prone to a number of natural disasters such as earthquakes, as well as wind and rain storms. Fig. 23 shows a fallen tree which fell due to a recent storm in the area. Heavy rain has caused an ample amount of damage to the built structures in the Wah Gardens. As mentioned earlier, the baradaris were badly damaged during the early 19th century and were later restored by the Department of Archaeology in 2014. Continuous penetration of rain water is causing the structures to disintegrate. The built structures are prone to several cracks and seepage (ICOMOS, [1965](#)).

Tree Fallen due to Storm

There is no possibility of the prevention of natural disasters, although timely planning and maintenance could secure the Wah Gardens from further damage. A planning team should be formed to meet the appropriate needs.

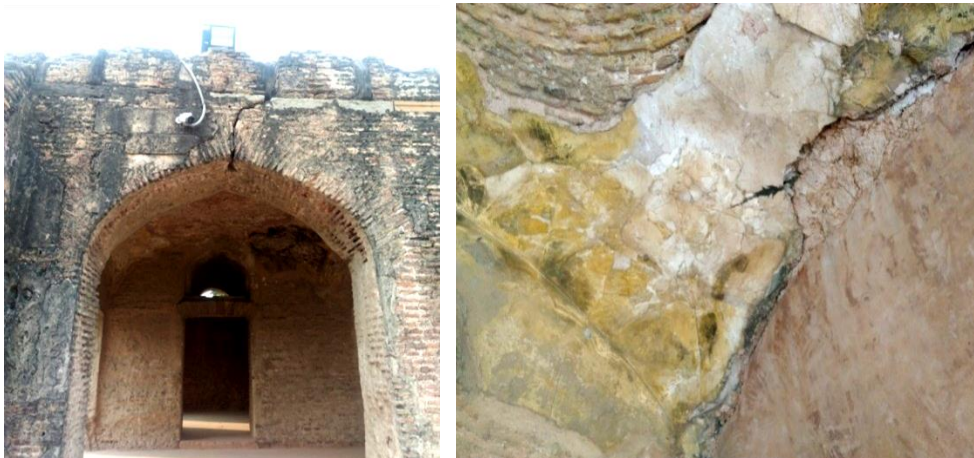
Figure 24

Cracks in the Baradaris

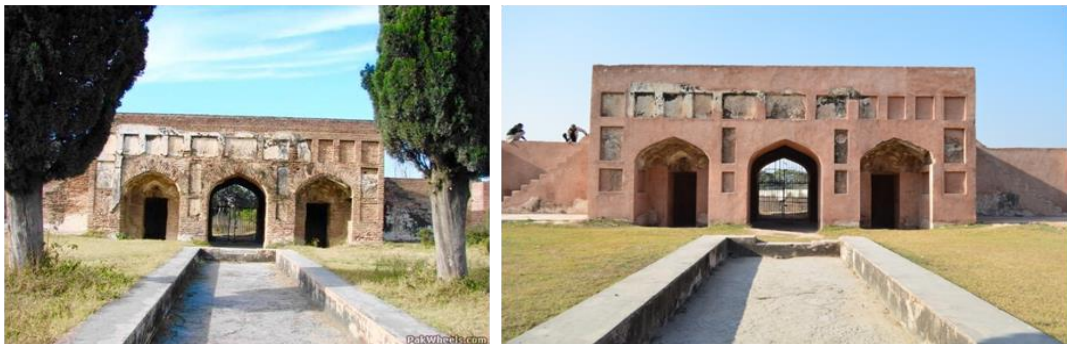
Figure 25

The original material for plaster was lime and the colour of the structures was beige white (Khan, [1992](#)). During the conservation project of 2014, red surkhi, chopped jute, grey cement and unslaked lime was used for lime terracing which totally changed the colour of the baradaris, western gate and the turrets (ICOMOS, [1965](#)).

Before and After, Condition of the Western Gate

The original methods and materials are proposed to be used for the conservation of the architectural features of the gardens. The previous conservation of the gardens needs consideration as it lacked authenticity. Thereof, plaster should be removed and the original lime plaster should be applied after proper study and material testing so the building context remains the same.

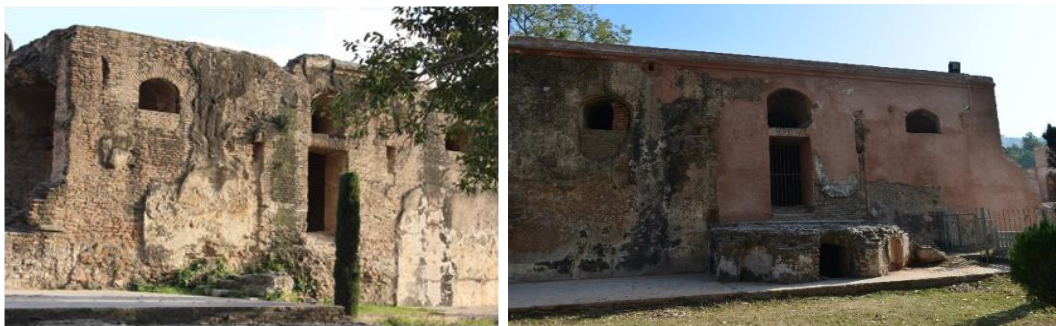
Figure 26

Before and After, Condition of Baradaris (Western Façade)

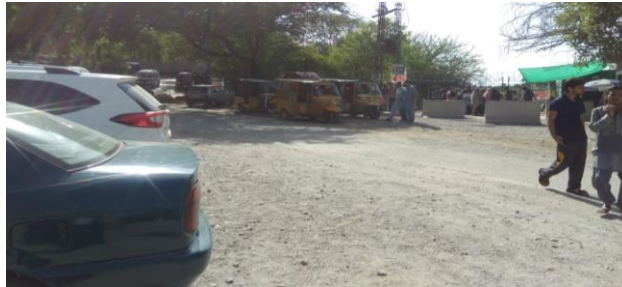
Figure 27

The absence of a proper space for parking vehicles causes traffic disturbance as the same road is used to access the Wah village and the adjacent areas. Due to a huge number of visitors in the summer season, the southern wall is used for parking purpose. The parking area is also not covered and protected against severe weather conditions (ICOMOS, [1982](#)).

Parking Condition at Wah Gardens

Visitors face a lot of disturbance in the congested road side parking. During summer season, the visitors are double in number as compared to the winter season and require more area to park their vehicles. The area in front of the Wah Gardens should be utilized for that purpose, so the gardens may accommodate more visitors. Construction needs to be done keeping in view a futuristic approach as the number of visitors will be increased further in the future. The already constructed structures in the marked area should be cleared and proper parking ought to be planned along with the green belts.

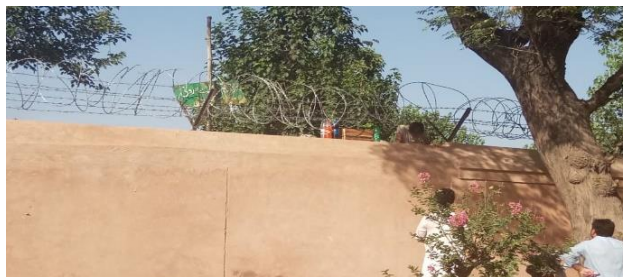
Figure 28

Wah Gardens are susceptible to security and maintenance threats as only a total of five staff members are dedicated to Wah Gardens (Gohar, [2018](#)). Security cameras are not monitored at all times. During most of the visits to the garden by the researcher(s), no security guard was available. The gardens cover an area of more than 157 canal and only two gardeners and sweepers are available for the maintenance of the area. Non-availability of guards near the built structures causes human vandalism. Moreover, people could be seen climbing the ancient structures to buy edibles not available inside the gardens and leaving garbage everywhere, thus spoiling the beauty of Wah Gardens (ICOMOS, [1982](#)).

Boy Climbing the Structure to Sell the Goods

The only way to stop human interventions is to plan an effective security system. The security cameras present around the complex should be monitored all the time. The security guards ought to be present around the structures and in the Wah Gardens to impose fine on the spot. This would secure the Wah Gardens from the damage caused by tourists.

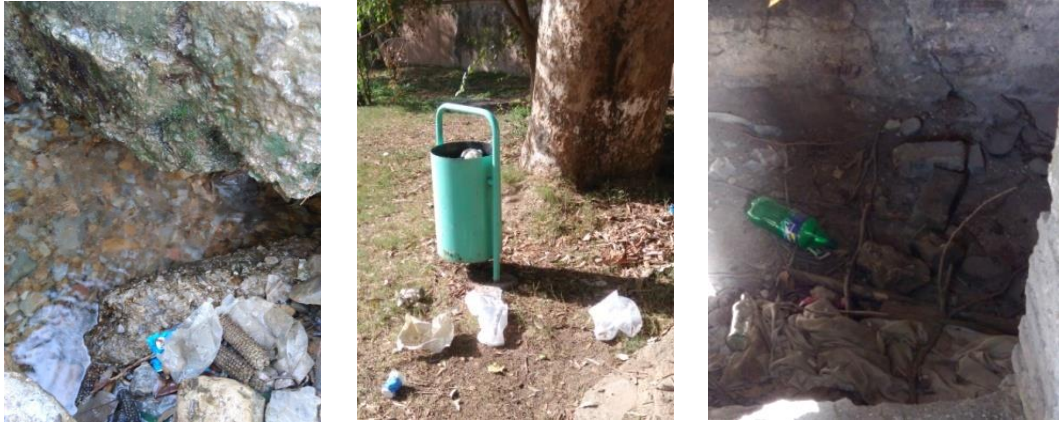
Figure 29

Garbage Disposal Spoiling the Beauty of Wah Gardens

The water coming from the natural springs is fresh, clear, clean and without any impurities. Indeed, the visitors spoil the aesthetics of the water tanks and water channels by throwing garbage in them. The water tanks and channels should be cleaned properly with fines imposed for human interventions.

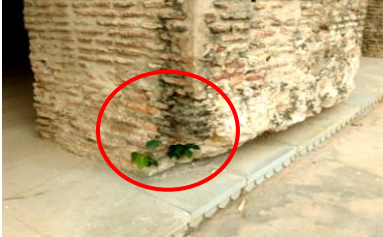
<p>Unscientific means of conservation. Fenced and closed for the visitors.</p> <p>Retention of rain water causing botanical decay. The structure's surface is leaving the ground.</p> <p>Removal of the original plaster and ornamental details from the interior of the baradaris.</p>

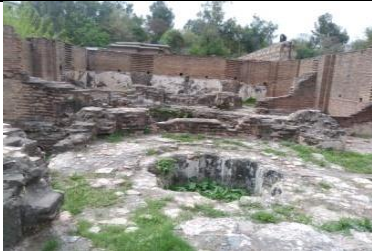
Closed for the visitors.
	Paen Bagh (Ladies' Garden)

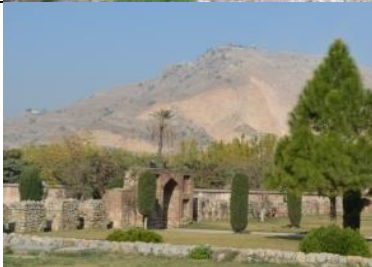
Used only by the ladies in the past but now open for all.
	Toilets

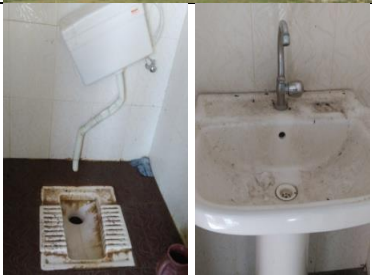
There is only one toilet open for the visitors (both males and females). The other remains closed. Poor maintenance.
	Canteen

The current tourist facilities such as the canteen, toilets and the few that have been recommended should be in harmony with the Wah Gardens. The red coloured coca cola advertisement on the canteen wall spoils the aesthetics of the Wah Gardens. Proper planning and an expert designer team is required for this purpose.

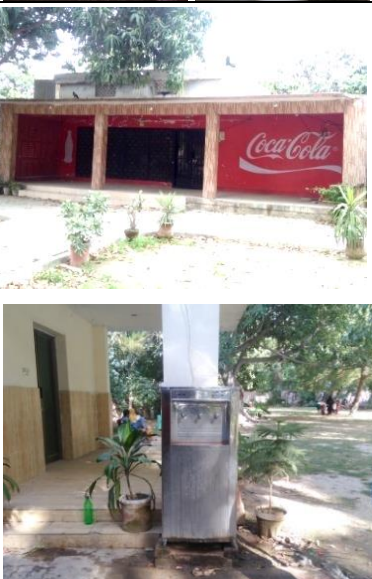
Remained closed throughout my visit to the site. Moreover, the structure is not in harmony with the historic garden. There is only one drinking water access in the 2 nd terrace.

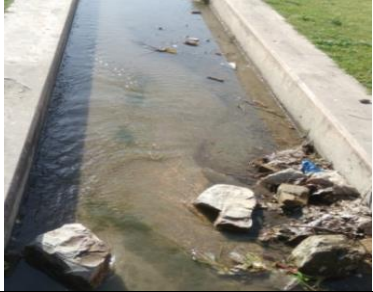
<p>Not maintained and filled with many obstacles and garbage.</p>
	<p>Landscape</p>

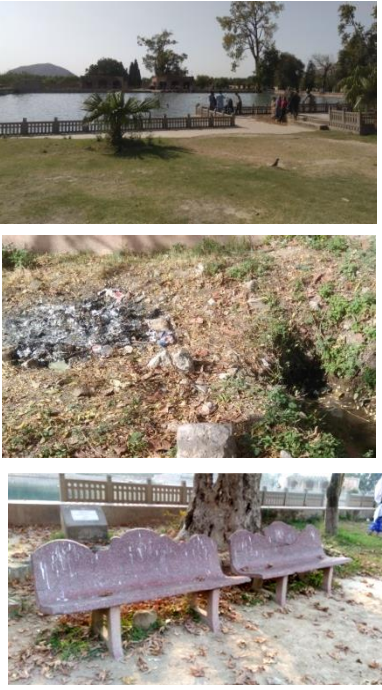
<p>The landscape of 2nd terrace is well maintained but few areas still need attention.</p> <p>The benches provided by the department in the middle terrace are not suitable for sitting as they are covered with bird waste.</p>
	<p>Central Water Canal</p>

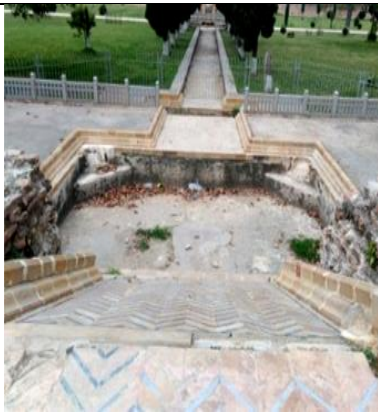
<p>Remained dry throughout my visit to the garden.</p> <p>The fountains are broken and not operational due to the collapse of water storage tank.</p>

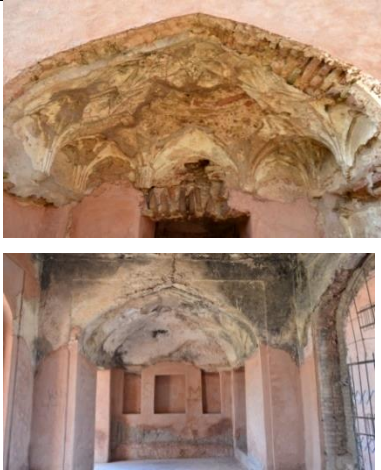
The use of inappropriate materials remains a threat for the original muqarnas details. Western gate is prone to human vandalism as the walls are covered with writings.
3 rd Terrace	Water Channels

Immediate action should be taken by the Department of Archaeology to remove banners from the garden walls and gates. Punishment and heavy fines need to be imposed to save the Wah Gardens from further damage in the future.

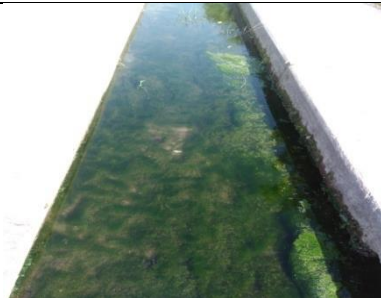
The water channel in the 3 rd terrace located on the southern side is filled with algae as water remains stagnant during summer.
