Title: Architectural Documentation for Cultural Heritage: A Case Study of Haribhai Pragji Karia High School, Karachi

Architectural Documentation for Cultural Heritage: A Case Study of Haribhai Pragji Karia High School, Karachi

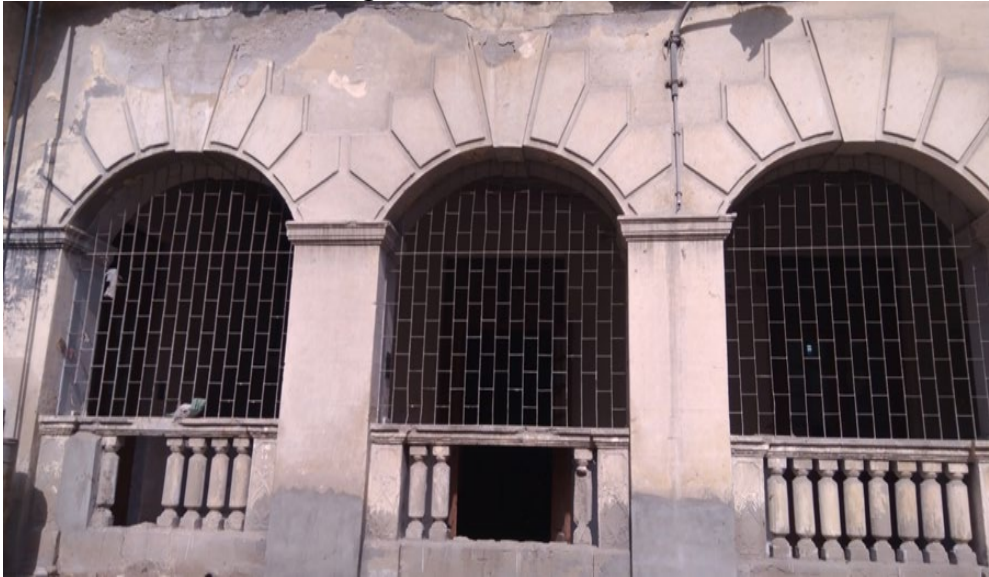
Figure 3

Pilasters, Decorative Cornice, and a Key Stone in Sunburst Pattern can be seen in this Window Creating a Frame

of that time. The building façade is a unique representation of the Anglo Vernacular, colonial, or domestic Gothic, where the regional features, such as the verandahs are combined with English features, such as the decorated entrance portals. The material of the main building is stone with a surface finish of color-crete supported on the load-bearing walls. The most frequent recurring architectural attributes of the colonial period in the building are the arcaded colonnaded porticos, with colossal columns, crowning cornices that project out to a certain level, and sometimes in the style of pediments and pilasters with a touch of Art Deco popular at that time. The windows have keystones in sunburst motive, one could also see chevron patterns on the arches of the colonaded verandas. The building features stepped facade, with a strong vertical emphasis through the columns, it has a forward looking feel to it in its spirit. The building is an iconic example of Streamline Moderne in Karachi which exemplifies the sleekness and fluidity of late Art Deco architecture. Its defining feature is the curved corners, which soften the building's otherwise bold, geometric facade. Horizontal lines are wrapped around the structure, echoing the streamlined aesthetics of contemporary design. The sweeping curves and smooth surfaces created by color-crete create an effortless flow, lending the building a futuristic appeal. This design choice, particularly evident in its rounded edges, sets the Hari Bhai Pragji building apart, merging modernity with elegance in a way that is emblematic of theaters and transportation hubs of the era. These features are beautifully amalgamated with regional features that include color-crete surface finish technique, mosaic tiles, grill ironwork and the cemented screen on top of the balcony, and ornamentations in floral patterns. Some of the notable architectural features found in the building are described as follows:

- Pilasters
- Colonnaded arcaded verandah
- Decorative parapet with a crown inspired by a pediment
- Entrance Portal
- CC Screen
- Colossal Columns
- Inscriptions

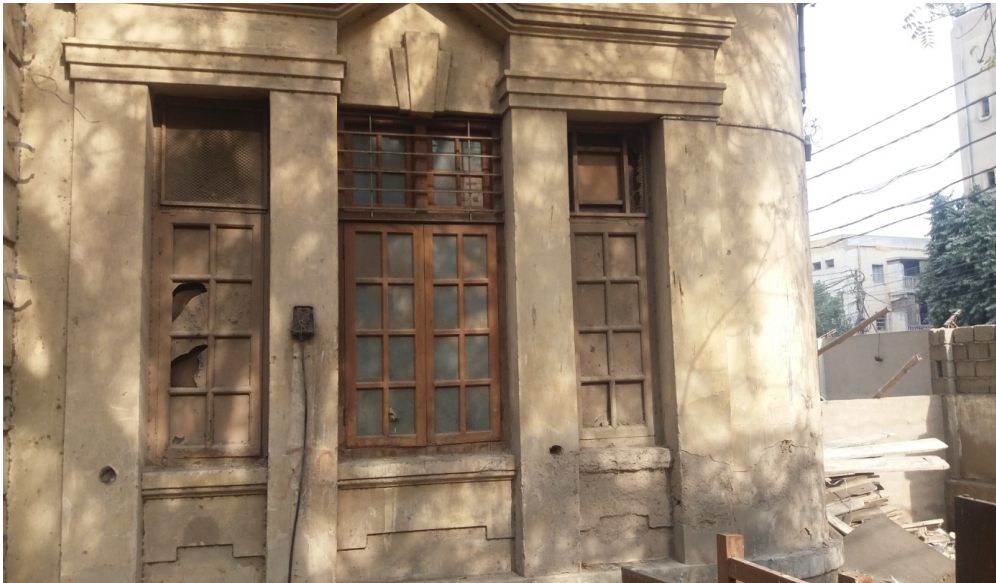
Figure 4

Arcaded Colonnaded Porticos with Chevron Pattern and Iron Grill Work as a Later Addition

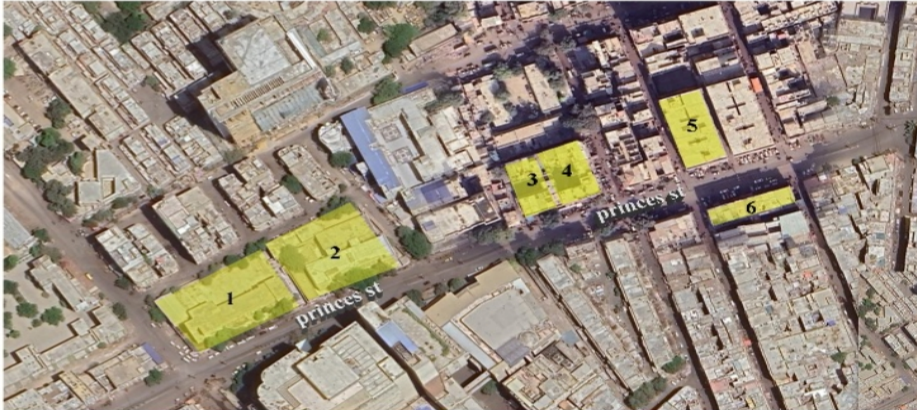
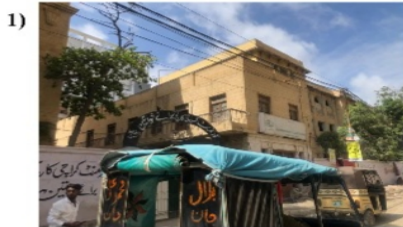
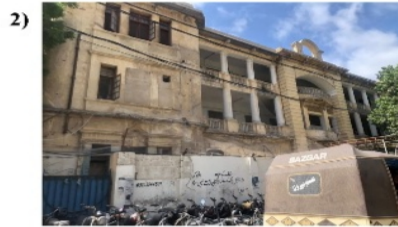
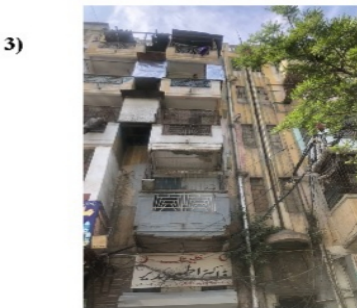
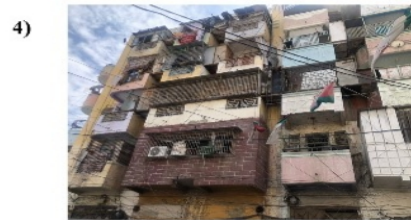
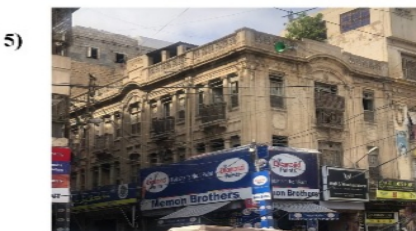
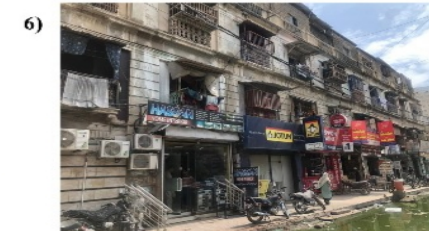
Figure 5

Google Earth Image, Showing Different Buildings Around the Site

Government women college

**Haribhai High School
(Dow boy's hostel)**

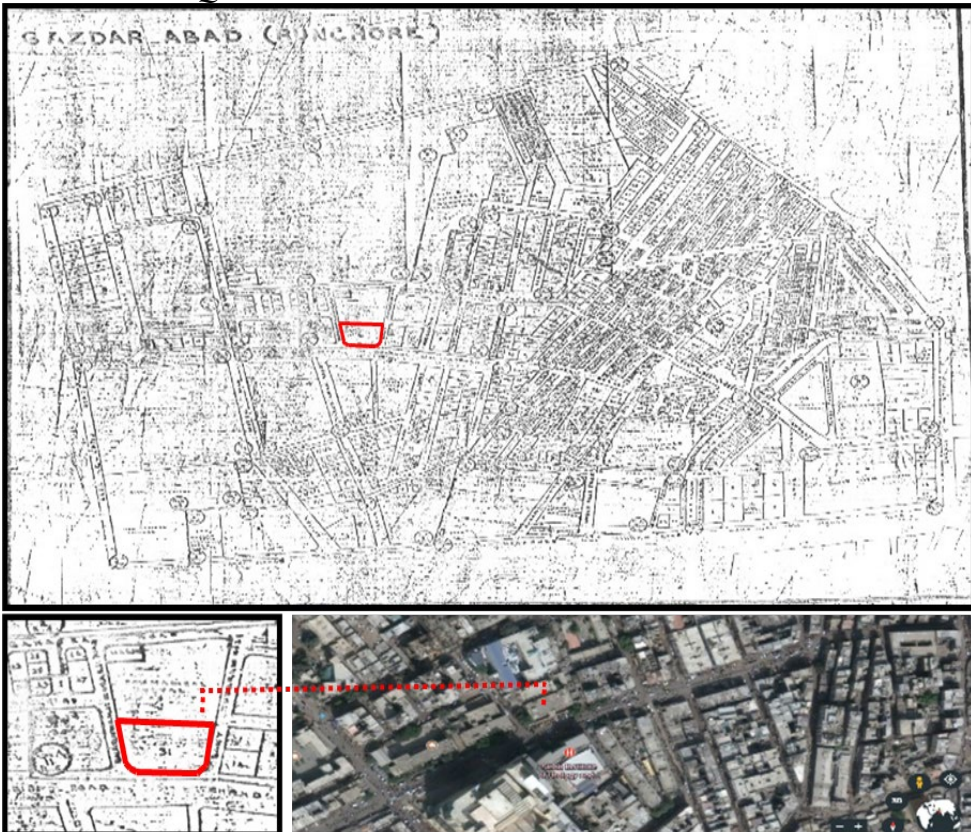
Figure 6

Location Plans of the Doctors' Mess Building Situated on RAN – 11/31 in Ranchore Line Quarter

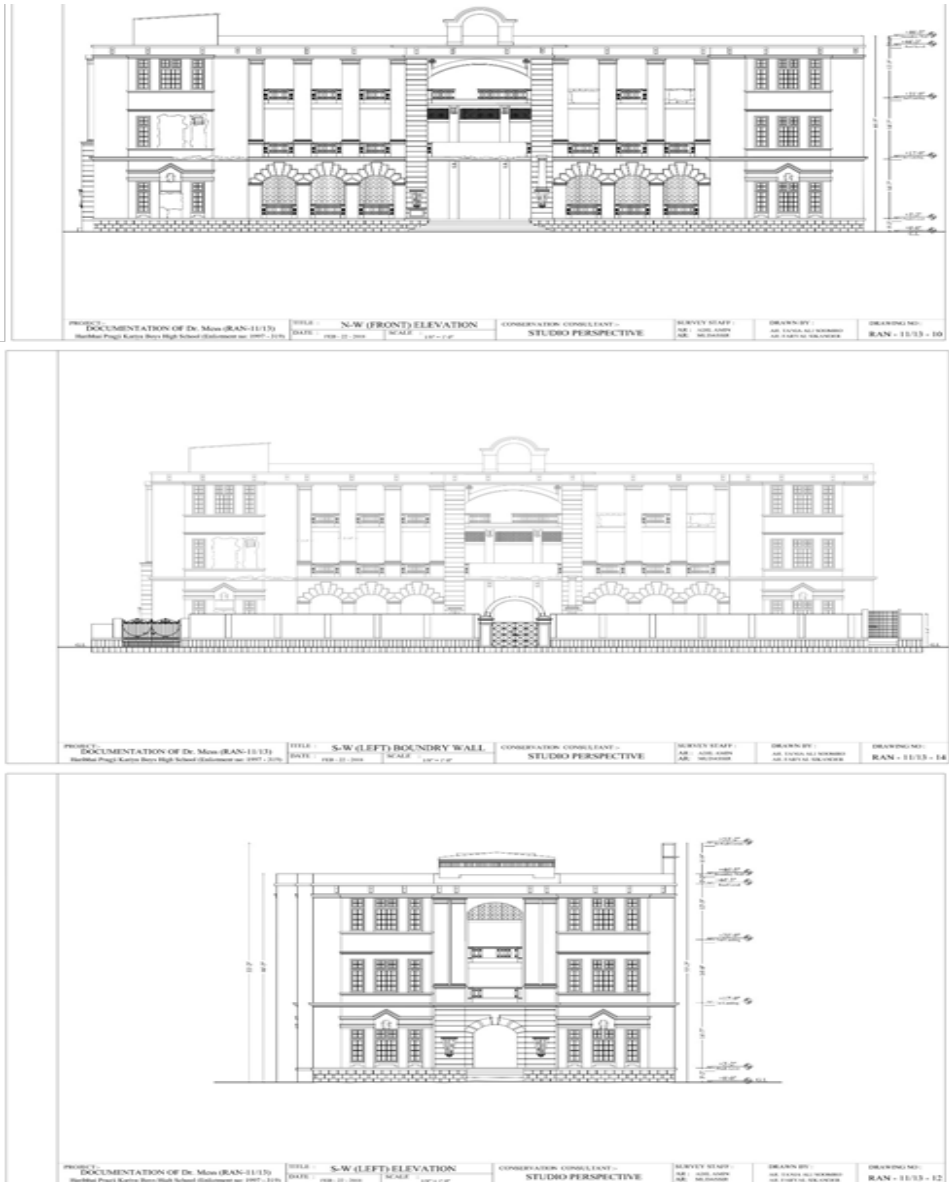
Figure 8

Measured Architectural Drawings of the Doctors' Mess Building – All Elevations

Following the manual measurement of all the dimensions on paper, the data was processed and turned into AutoCAD drawings that contained all plans, elevations, sections, and details. Since the drawings were digitized on-site, as previously mentioned, the process went quite well. Resultantly, all technical issues that arose during the documentation process were resolved immediately, greatly reducing the time needed. Due to the digital drawing, the building's minute characteristics were understood and reflected upon.

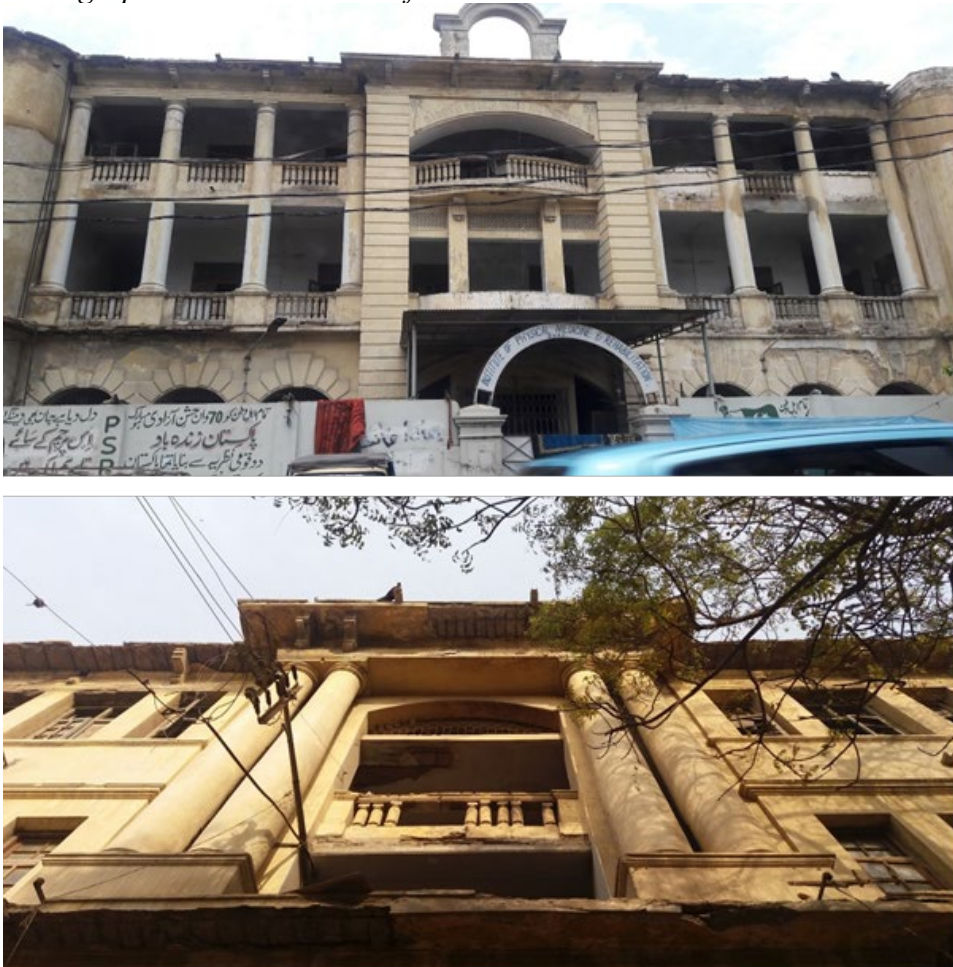
Figure 9

Photographic Documentation of Doctors' Mess

Photographic documentation was an equally significant step as the measured architectural documentation. Photographic documentation was carried out to document the building graphically. The details, which could not be documented manually, were also documented through photographs. A simple DSLR camera was used to capture high-resolution images of the building. Images were rastered in AutoCAD to develop good-quality details.

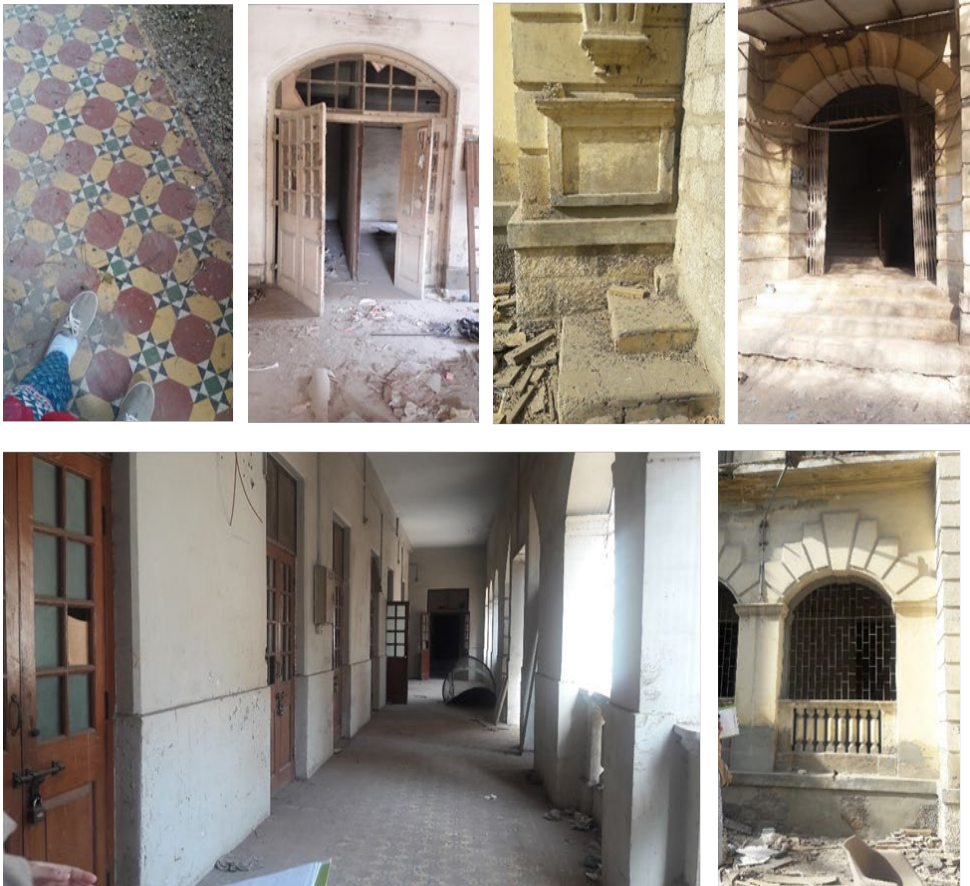
Figure 10

Photographic Documentation of Doctors' Mess – Detailed Images of the Interior of the Building

Photographic documentation was not only essential to the measured documentation process, however, it also played a crucial role in establishing the analysis. For multiple reasons, some of the areas within the building premises were inaccessible. However, it was simpler to comprehend the building's dimensions and unreachable proportions with the aid of precise photos taken. The broken staircase and the waste dump restricted several regions including the back alleys and the stairs leading to the rooftop. Thus, photography was helpful in that situation. Photographs were taken in other similar regions as well. Figure 9 shows a few of the building's detailed photos for a reference.

The current condition of the building depicts various issues that require a blend of approaches to restore the building. The building presents elements, such as pilasters, cornices, original windows, doors, mosaic flooring, and iron staircase grills that are still largely intact, however, need some restoration. Nevertheless, there are significant issues that require immediate attention. The building façade has suffered from biological growth, poor maintenance, and improper alterations, such as blocked window openings and the presence of metal projections. Rainwater, improperly draining onto the façade, has exacerbated the damage. Exposed electrical wiring and later additions, such as cement plaster and unnecessary partitions, are further contributing to the building's decline.
