Journal of Art, Architecture and Built Environment (JAABE)
Volume 7 Issue 1, Spring 2024

Integrating Architectural Heritage with Environmental Concerns: A Case Study of Clock Tower, Faisalabad

Bazla Manzoor, and Nazia Iftakhar*

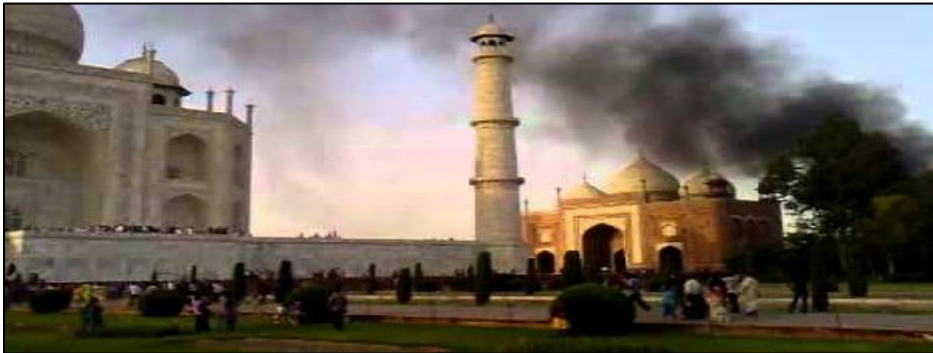
Figure 1

emissions from vehicles was responsible for turning the color of The Taj Mahal to a brownish-yellow form (Chandan & Kumar, [2019](#)) as shown in Figure 1. The administration tried to preserve it through architectural preservation and by using rich lime-rich Fuller's earth (Multani Mitti) to give a clay pack treatment to save the original color of the monument (Bhattacharya, [2008](#)). Shahdara Complex in Figure 2 is located near the Grand Trunk Road and the large industrial area of Shahdara, Lahore. Over three centuries, the environs of this complex had been transformed from lush green gardens to an area with large industrial areas and heavy vehicular traffic. The primary factors for deterioration are atmospheric pollution, the transmission of salinity to the main masonry through capillary action, and heavy rainfalls in monsoons in the absence of a rainwater management system at the complex (Abbasi & Jabeen, [2021](#)).

Air Pollution Affecting the Taj (Rizwanurrehman89, [2011](#))

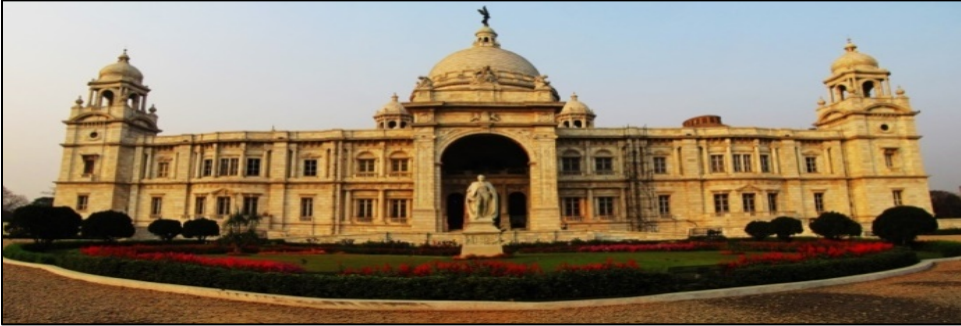
Figure 4

Similarly, the Victoria Memorial is a monument from the British Era in Calcutta (Figure 4), constructed in 1921. Unfortunately, its magnificent exterior has deteriorated with time. A microstructural investigation on the cause of deterioration indicated that the expanded absorption of pollutants and hydratable salts has given rise to crystallization damage to sandstone (Roy & Kalidindi, [2017](#)). The mortar joints of the building had been split up and it is undergoing a substantial loss of artistic magnificence. The Gateway of India was built in Mumbai by the British Government near the Arabian Seashore. It was planned to be built in 1911 to celebrate the arrival of Queen Mary and King George at the Arabian Seashore in Mumbai but was built in 1924. This magnificent monument was designed by Mr. George

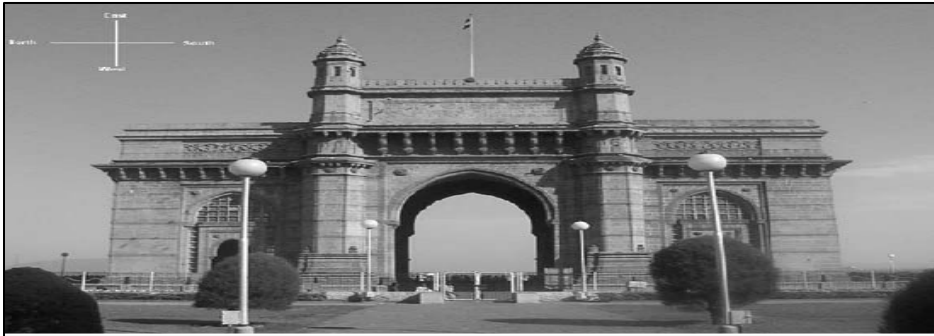
Figure 5

Wittet during 1912-1913 (Figure 5). Researchers have used color measurement techniques to quantify the color change in stones. It was observed that the color of the stone changed due to environmental effects (Tiwari, [2005](#)).

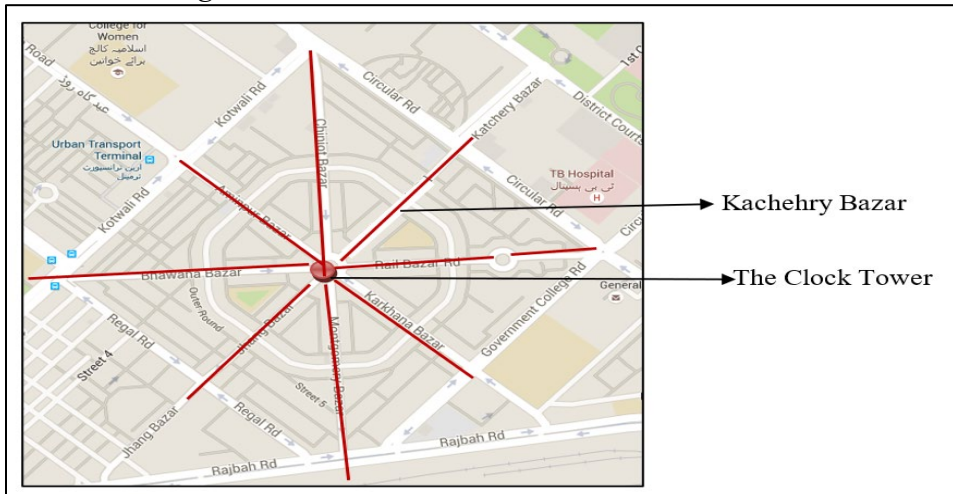
Figure 23
Current Parking Plan

Correspondingly, to make the surrounding area of the Clock Tower relatively green, it is suggested to make the area pedestrianized. According to the existing situation, vehicles are allowed to move in every bazaar up to the Clock Tower. The traffic flow can be controlled by restricting the entry of vehicles in Gol Bazar. In this way, the adjacent area can have less air pollution, thus the building structures can have less adverse environmental impacts. Old residents of Faisalabad claimed that Gol Bazar was designed

by the British Government as a parking area. As there were very less cars at that time, therefore, people constructed shops there with time. The parking around the Clock Tower is required to be re-planned in order to minimize the air pollution around the Clock Tower to some extent. The current and proposed parking plan is shown in the above Figures 23 and 24.

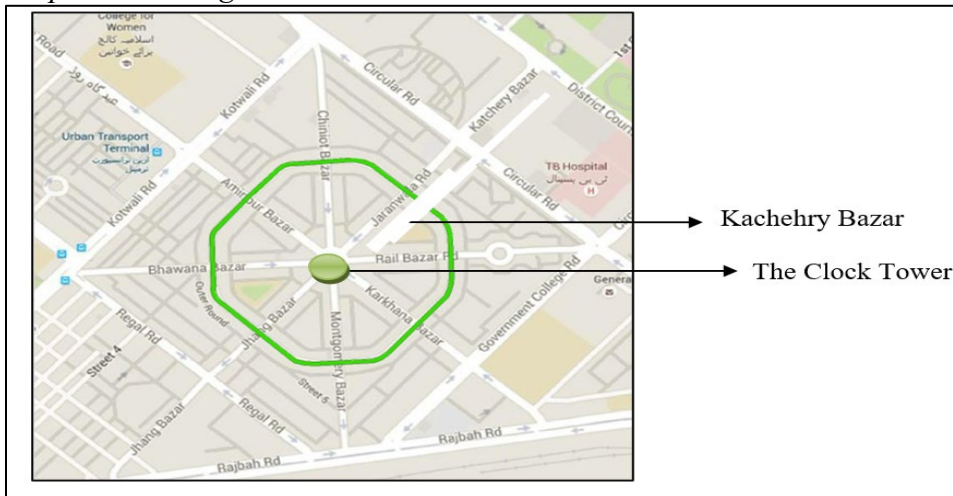
Figure 24
Proposed Parking Plan
